RAIL Top 25 1082- IGV Arm Bearing Failure

RAIL Mechanical Queue 1084- 36-150(EMB) LOP Switch

RAIL Top 25 1085- W5 Wire Harness Issues – 3034427-3

RAIL Top 25 1086- AS907 Thrust Reverser (TR) Long-Term Solution

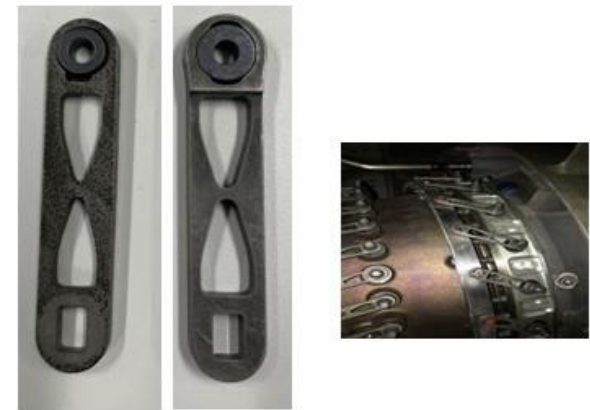
Current 3033050-4

- Wear of IGV/CGV arms result in loss of spherical bearings
- Excessive bearing loss can contribute to compressor surge

- Released SB 72-9001 to address bearing retention in service
- Incorporated interim SB solution into production at engine
- All LMMs were revised to allow fly-on for 25 hrs with one to ten uniballs missing

- Corrective action underway
- Improved configuration selected – 3033050-4
- Testing complete
- Test results and certification reports are being prepared for review
- Service bulletin estimated in Q4 2025 based on hardware availability
- Redesign can be mixed with original configuration

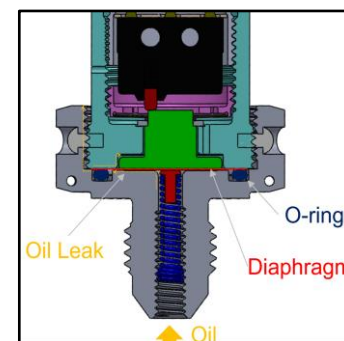
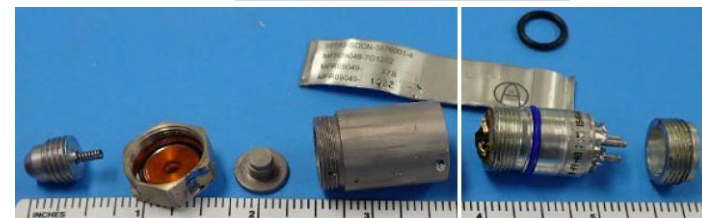
3876001-4 Low Oil Pressure switches are failing frequently on the 36-150[EMB] APUs, resulting in No-start and AOG and is a top delay and cancelation driver

- Honeywell to improve the robustness of the -4 LOP switch
 - Improve O-ring to prevent internal oil leakage
 - New internal o-ring selected with improved thermal capability and improved compatibility with APU oils
 - Improve switch body to prevent twisting due to torquing of the hex and body fittings
 - Added extra screw in lower section next to hex nut to increment torque capability.
 - Body structure updates to improve robustness
- There will be no change to the HON P/N; supplier part number will change from 7G1202 to 7G1247. A S/N cut in point will be made with no overlap between the two supplier P/Ns.

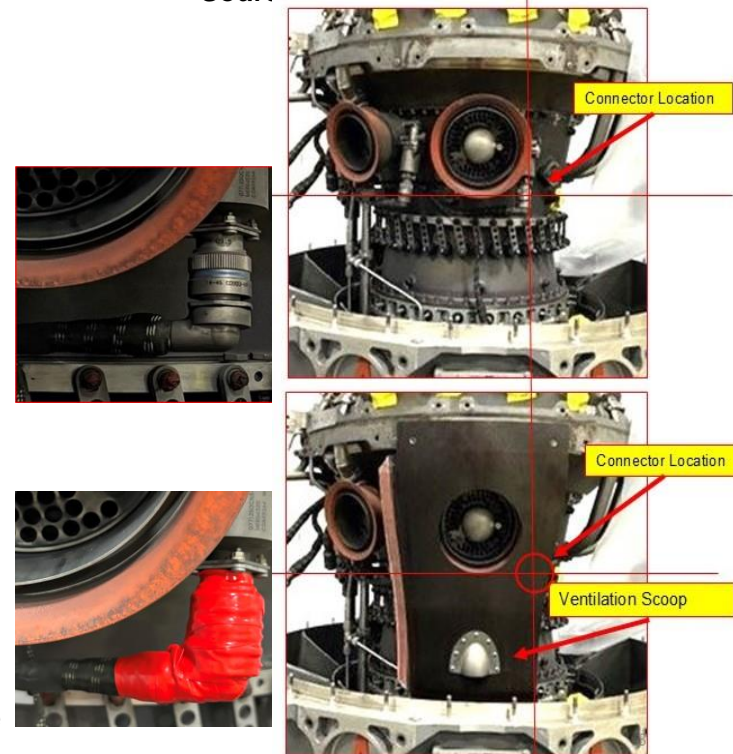
- Increased quantity of W5 harnesses are being rejected

- Lack of specifics (resistance values, inspection results, etc.) during field investigation (grip it and rip it)
- Field investigation (ohmmeter, megger, visual) cannot always identify an issue caused by operational inputs – vibration / heat & expansion

- Service Information Letter issued
 - SIL D202401004213 Issued Feb 2, 2024
 - “A Discussion Regarding the AS907 Wire Harnesses; Issues and Investigation”
 - Requests specifics; provides investigation steps
- Service bulletin to apply self-vulcanizing silicone tape to surge bleed valve electrical connectors
 - SBV B is near inner fan bypass panel air scoop
 - Subject to water, dirt, etc.
 - Service bulletin in sign off – target Q2 2025
- Will be incorporated into new engine production

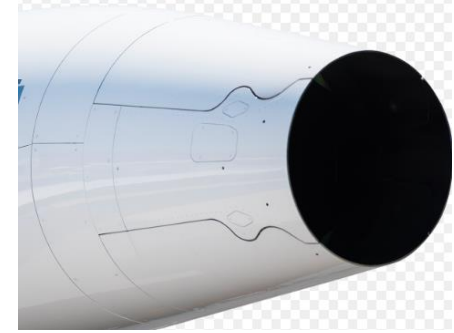
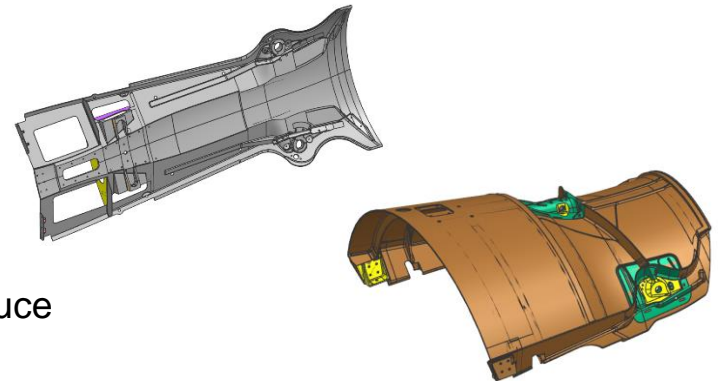
The GCC committee has requested HON to provide a long-term solution for the AS907 Thrust Reverser coating issues

- Thrust Reverser concept development
 - TR Doors composite with embedded titanium interfaces
 - TR Beams dual-pathed with an all-titanium version and a composite/titanium hybrid both being considered
- Replace painted aluminum with materials that won't corrode or require coatings
- Early supplier engagement to ensure manufacturability and reduce design iterations
- The new Doors and Beams design intent to be “drop-in” replacement
 - Assembly will prioritize reuse of existing unaffected components
 - No modifications of existing components/no machining
 - Simplifies upgrade in the field at Service Centers/Channel partners

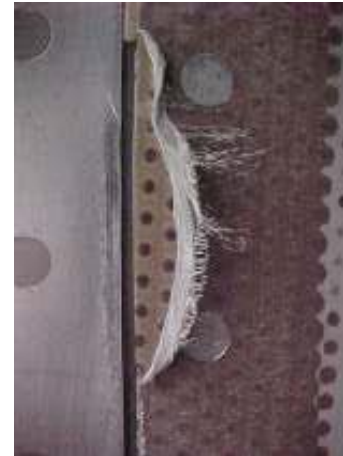
**Inlet Screen Peeling at Leading Edge**

- Inlet screen peeling addressed by GKN technical variance GKN-TV-9020E Allows repair of inlet peeling 360 around inlet circumference
- Inlet Barrel Screen Blistering, GKN introduced a redesign of the screen installation in Mid 2018
 - Prevents contact between stainless steel mesh screen and aluminum honeycomb

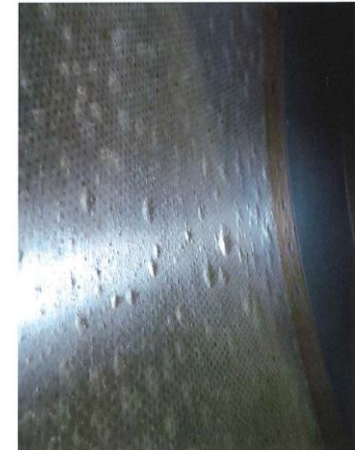
**Inlet Barrel Blistering**

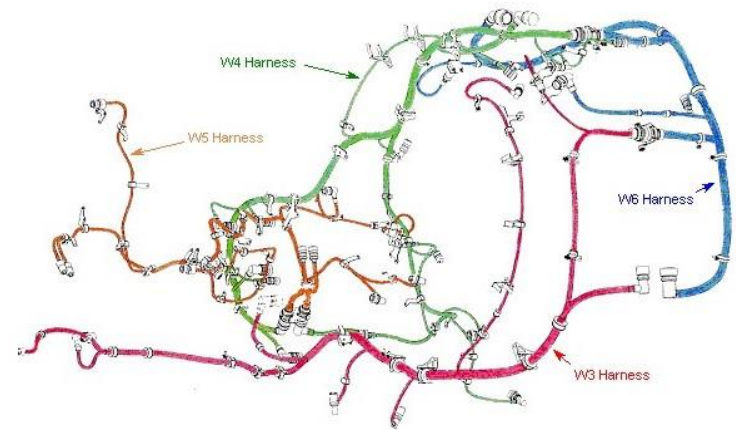
Request Field Repair for Wire Harnesses

- Outer braid repair created for W3 harness
 - Damage from Fan Cowl Door hold open rod
 - SB 76-9033 released January 2025
- Outer braid repair for all wire harnesses
 - LMM revision to harness inspection / check created
 - Refers to Repair Manual for outer braid repair
 - Applies self-adhering silicone tape
 - Will be incorporated as each LMM is revised
- Field electrical repairs: Not allowed / advised

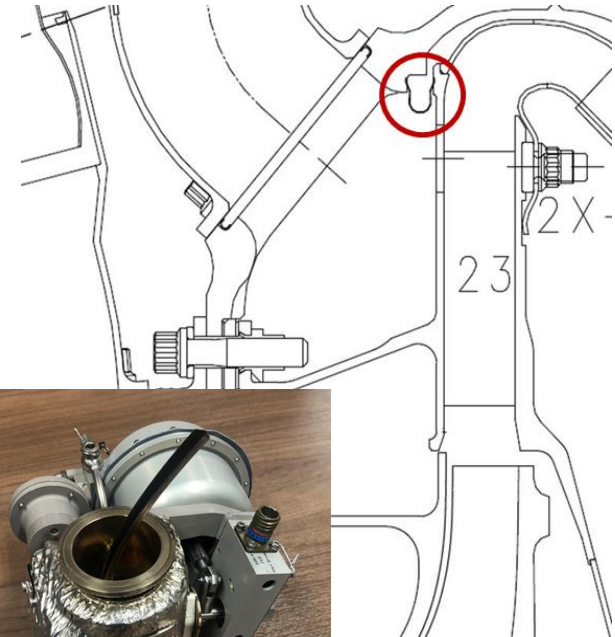
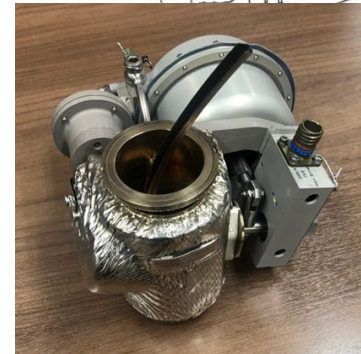
- Field reports of Diffuser "V" seal separation results in AOG situations due to V seal piece lodging in anti-ice valve
- V seal had issue in 2017 – 2019 and was corrected
- Issue has reappeared

- Chief Engineer has requested complete, in-depth review of V seal interfaces, materials, design intent, temperatures, growth, etc.
- Initial actions have been initiated.
- Timeline of events since initial redesign created
- Will be long term, throughout 2025

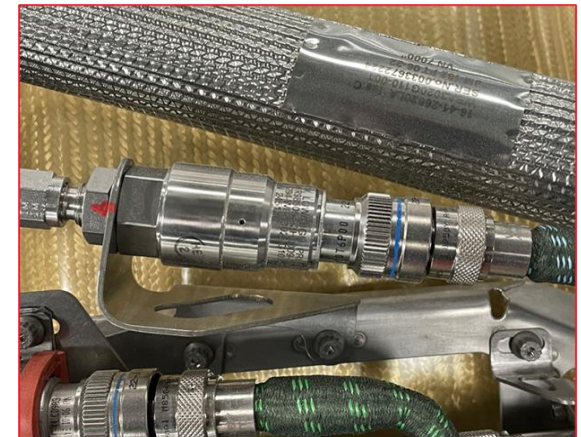
- Anti ice valve (ASC) investigated and given green light
- Cause of field events related to anti-ice switch PN WBA3020G103-007
- Investigation determined issue is with activation mechanism
 - Will activate, but not de-activate
- Issues with mechanism identified and redesign identified
 - PN to roll to -009
 - Proving a challenge
 - Unforeseen repeatability issue – delay
 - Target Q1 2026 for availability

- Increased production test from 500 to 1000 cycles
- Validates electrical circuit in addition to mechanical mechanism
- Interim actions have screened out infant mortality issue – low time removals almost non-existent

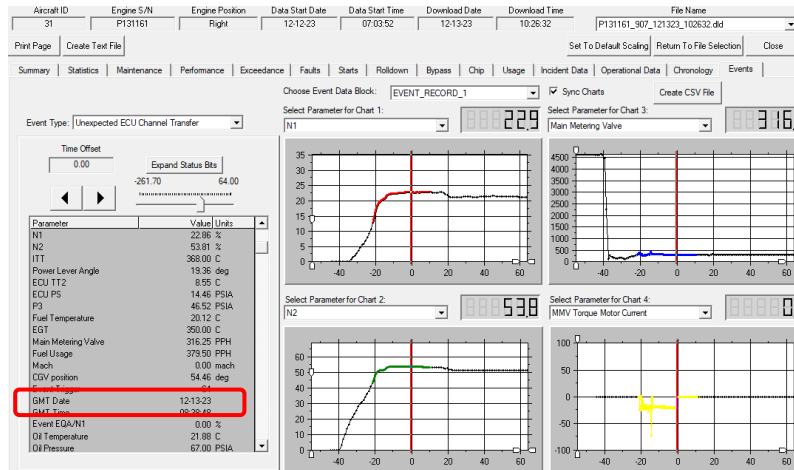
MMV current null MCID 133 occurs at time 05:38:57 after engine start complete

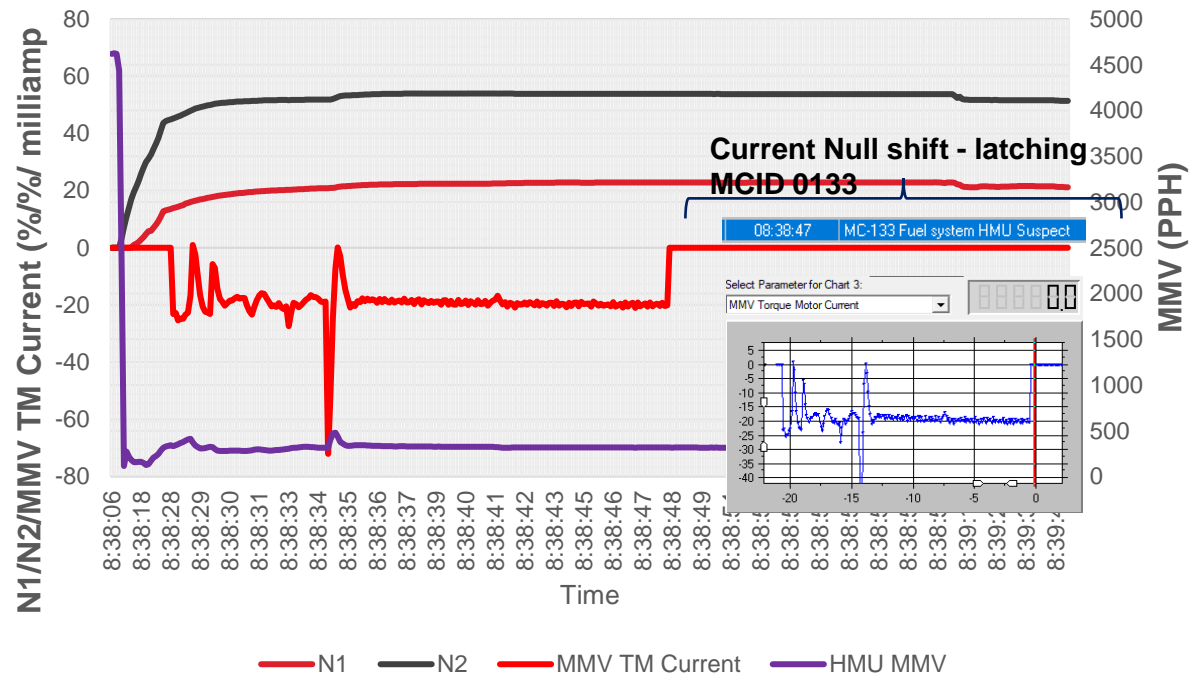
AS907-3-1E/P131161 - HMU fault MCID 0133
12/13/2023

Fault occurs after start (38 secs for the above event)

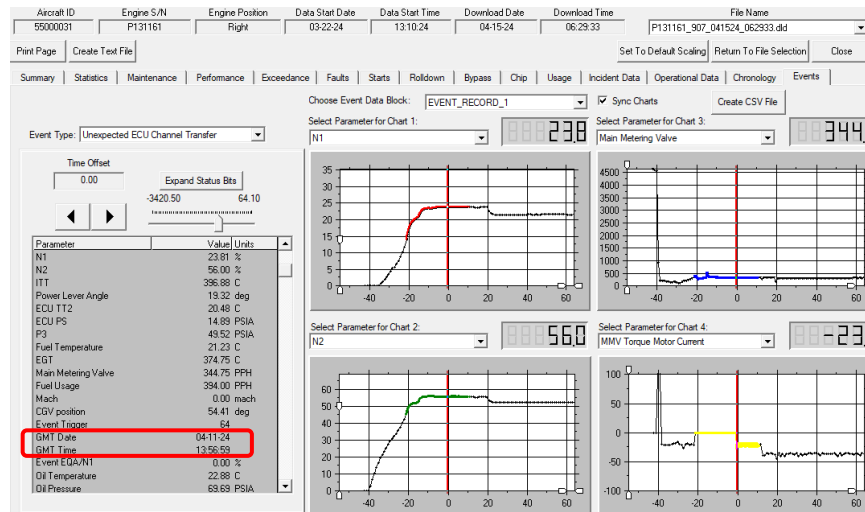
MMV current null MCID 133 only latched at time 13:58:59

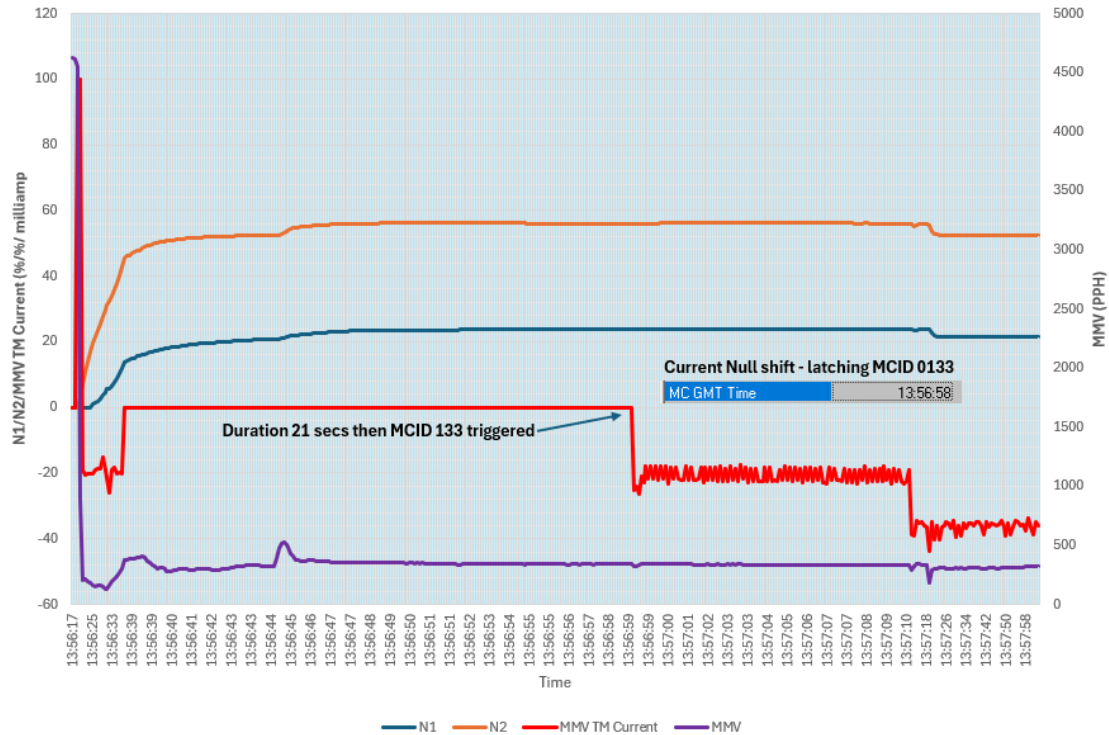
AS907-3-1E/P131161 - HMU fault MCID 0133
04/15/2024

MMV torque motor current Null total time duration 21 seconds

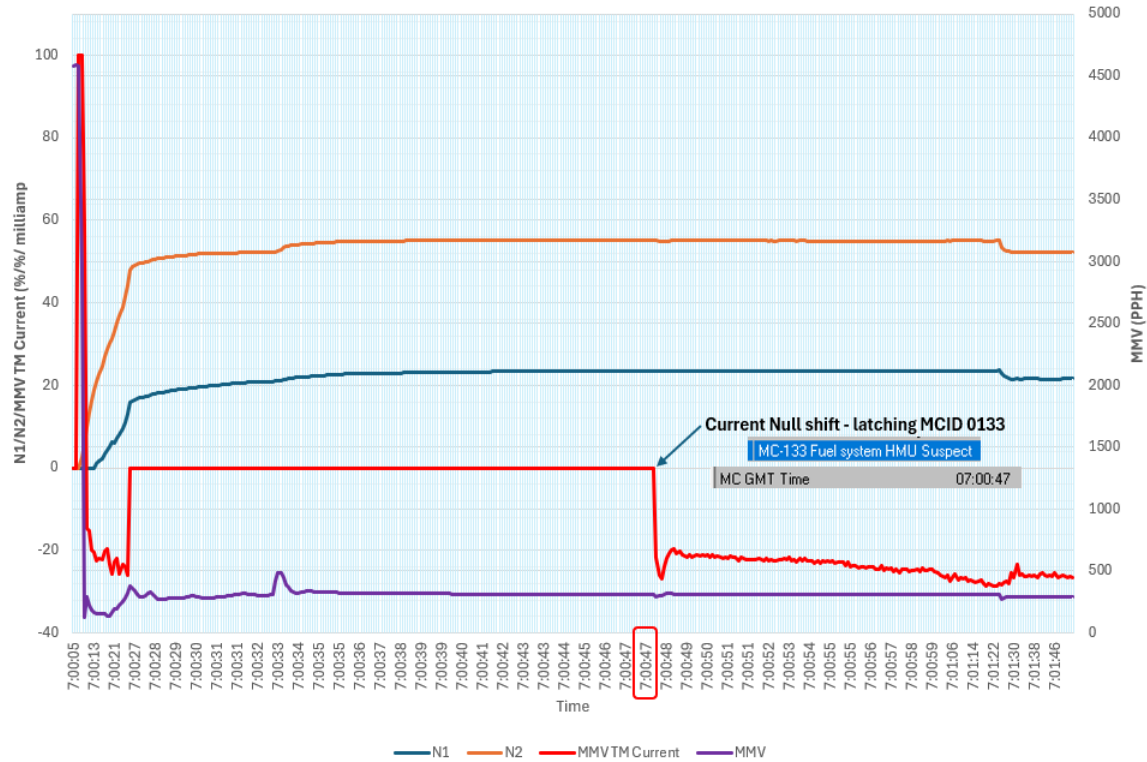
AS907-3-1E P131158 - HMU fault MCID 0133
6/19/2022

MMV torque motor current Null total time duration 21 seconds after engine start complete

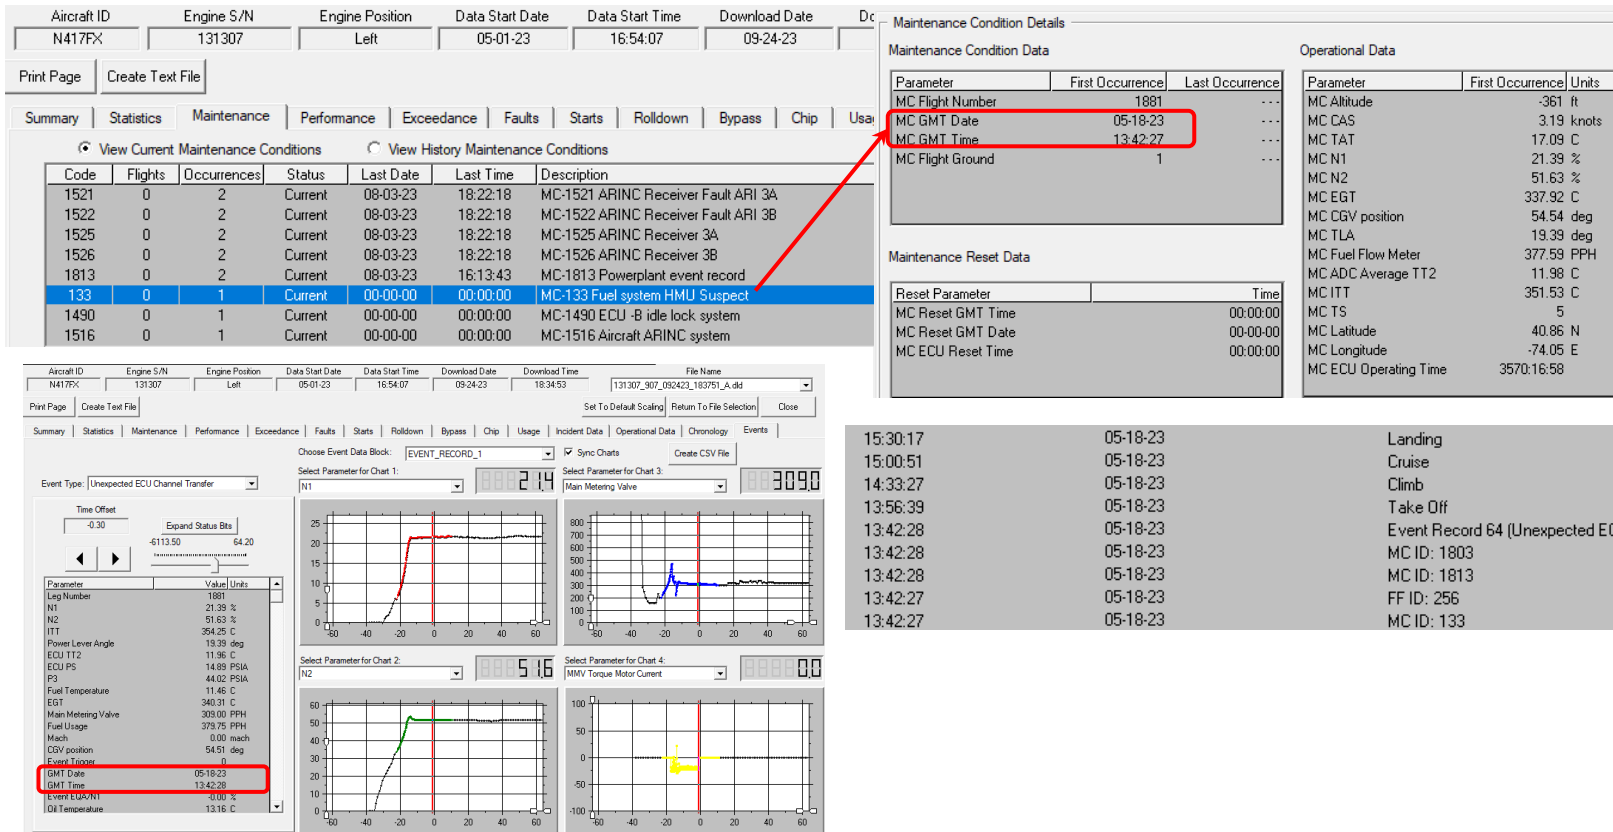
EEI REVIEW ENGINE P131307 – MCID 133

MMV current null MCID 133 occurs 8 secs after engine start complete

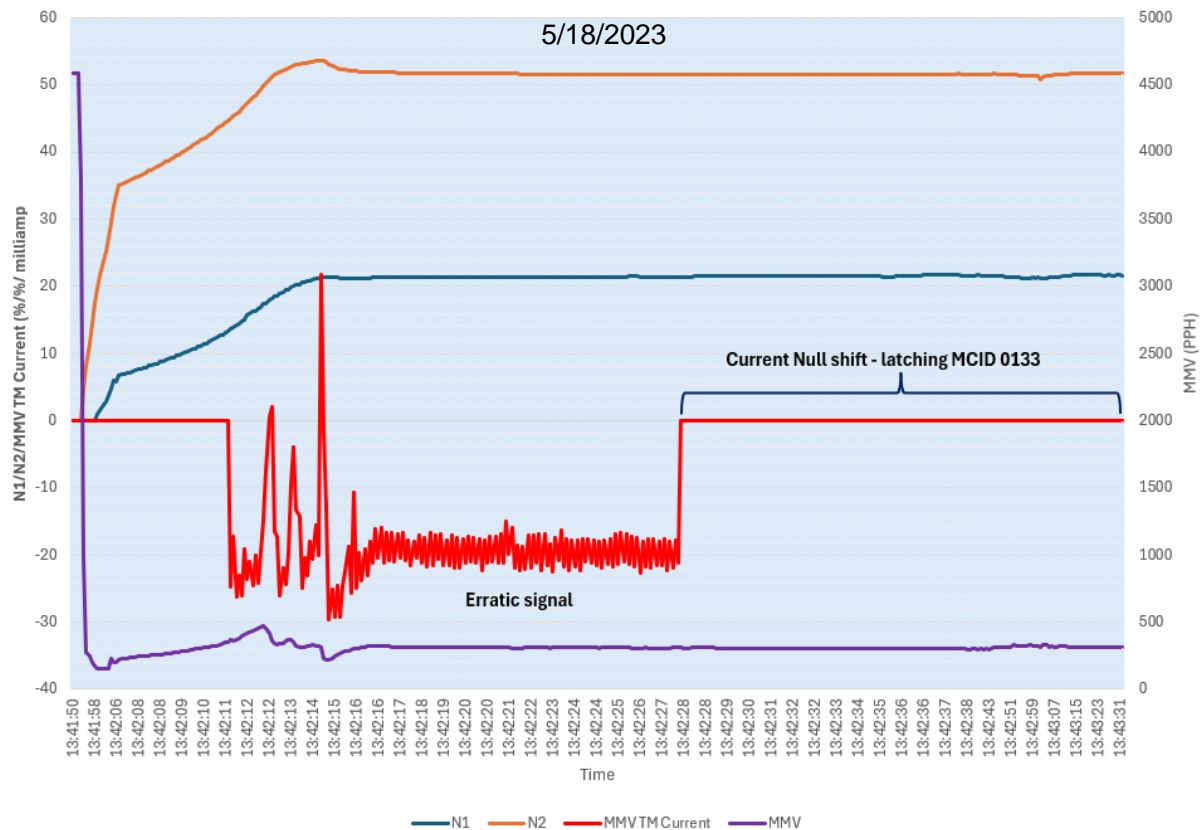
AS907-3-1E/P131307 - HMU fault MCID 0133

Typically occuring after start (38 secs for the above event)

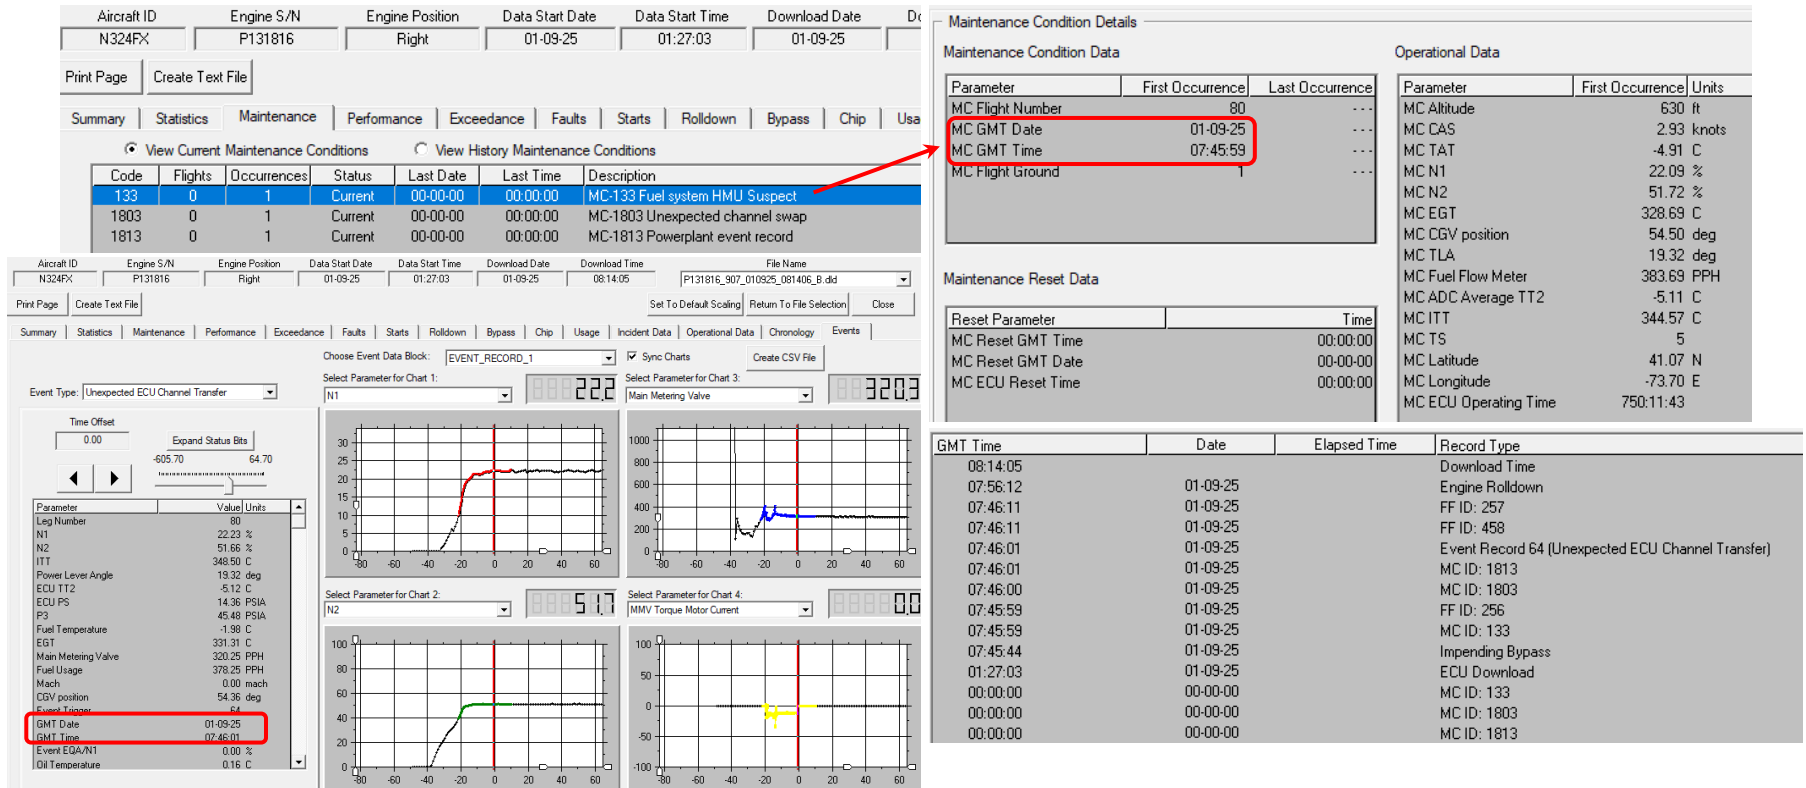
EEI REVIEW 1/9/2025 - ENGINE P131816 – MCID 133 DUAL CHANNEL RESULTED IN A NO DISPATCH CAS MESSAGE

MMV current null MCID 133 occurs 9 secs after engine start complete

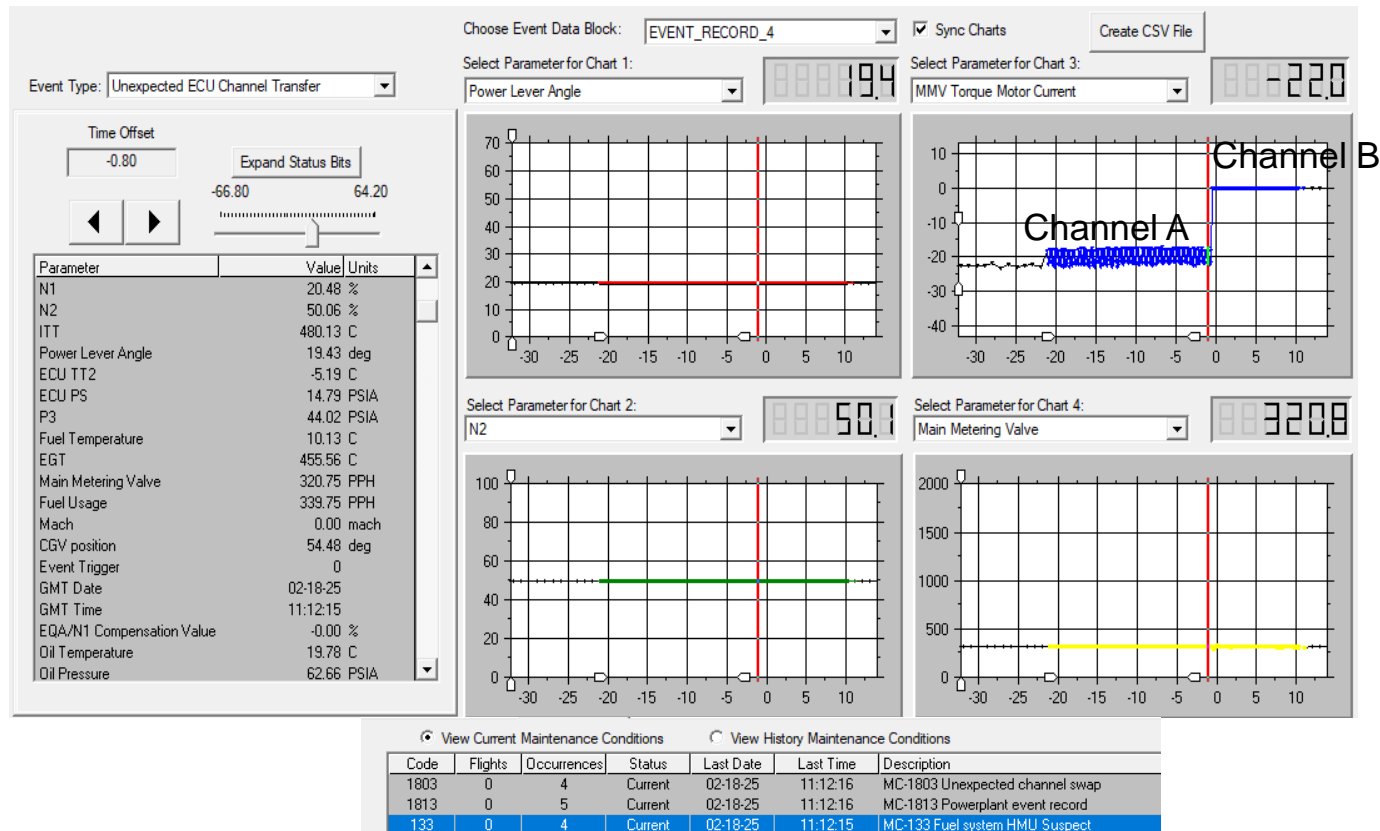
MCID 133 – DUAL CHANNEL FAULT

Local and cross channel fuel torque motor null shift indicated

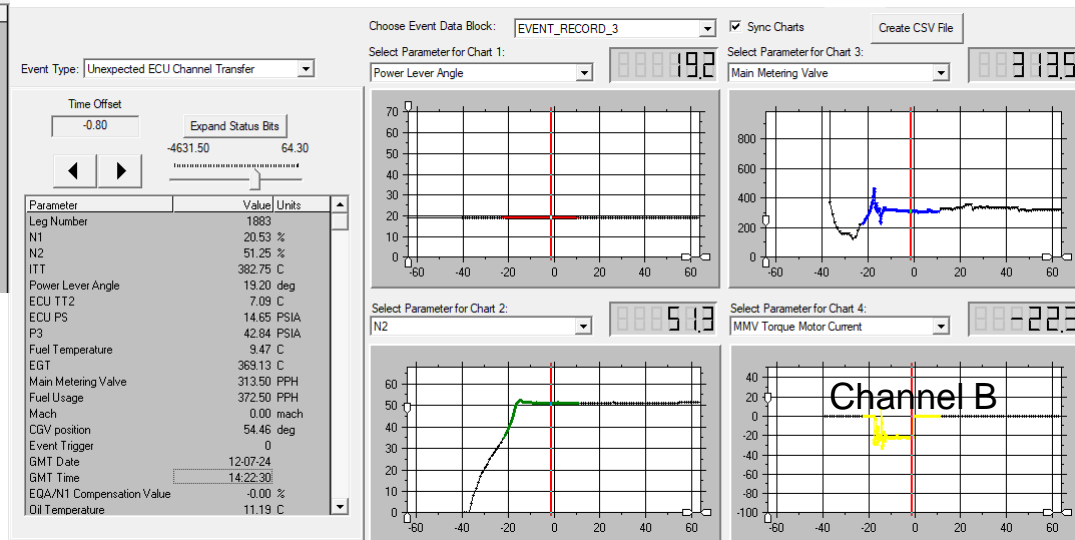
MCID 133 – LOCAL CHANNEL SINGLE FAULT

Local channel fuel torque motor null shift indicated

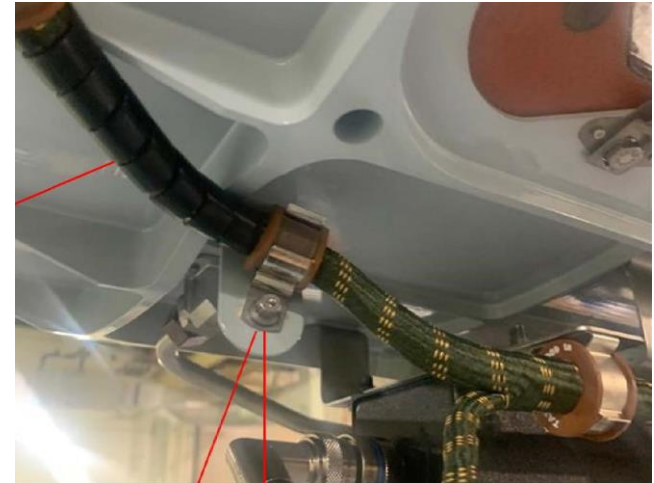
Fan cowl door hold open rod may chafe W3 harness over braid

- **Service bulletin 76-9033 released Q1 2025**
- Provides for application of anti-chafe sleeve (spiral wrap) and reposition of clamp to ensure adequate harness-to-hold open rod clearance
- Side Bar... Procedures to inspect cloth over-braid and apply anti-chafe sleeve will be added to LMMs and expanded to other areas of the harnesses
