RAIL Top 25 1082- IGV Arm Bearing Failure

RAIL Mechanical Queue 1084- 36-150(EMB) LOP Switch

RAIL Top 25 1085- W5 Wire Harness Issues – 3034427-3

RAIL Top 25 1086- AS907 Thrust Reverser (TR) Long-Term Solution

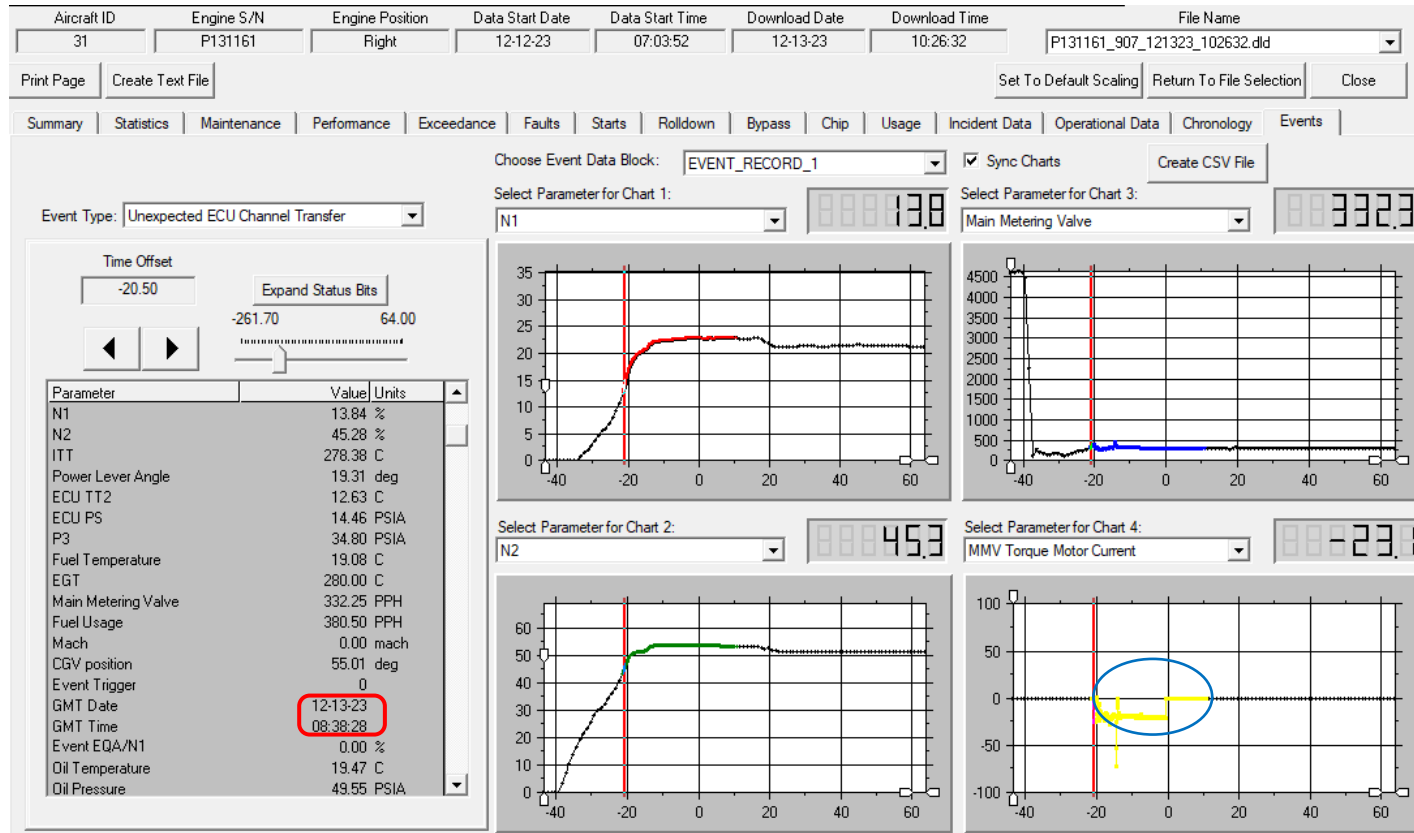
EEI REVIEW ENGINE P131161 – MMV & TM CURRENT

MMV current null MCID 133 occurs at time 05:38:57 after engine start complete

AS907-3-1E/P131161 - HMU fault MCID 0133
12/13/2023

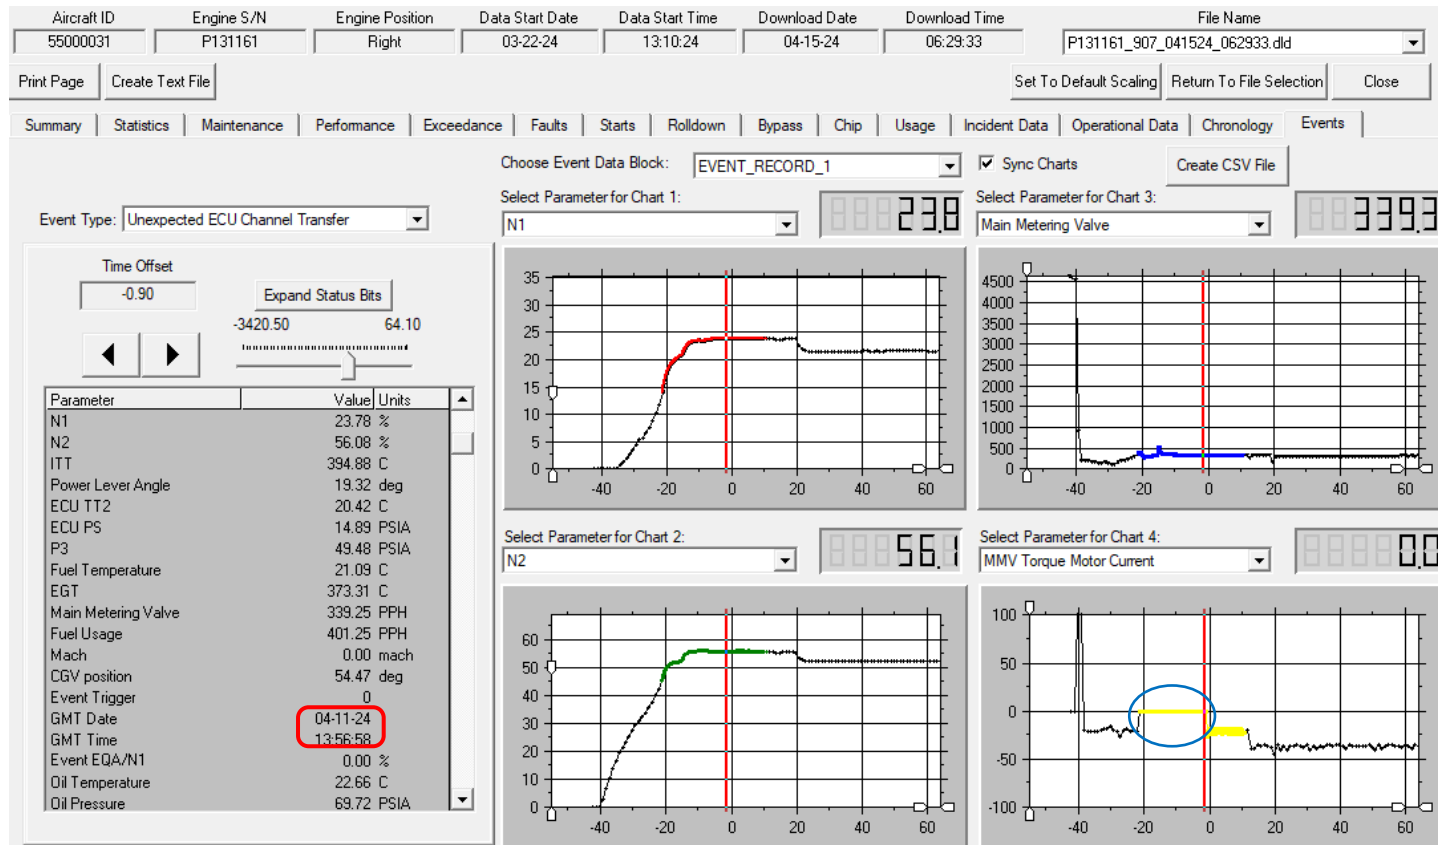
EEI REVIEW ENGINE P131161 – MMV & TM CURRENT

MMV current null MCID 133 only latched at time 13:58:59

AS907-3-1E/P131161 - HMU fault MCID 0133
04/15/2024

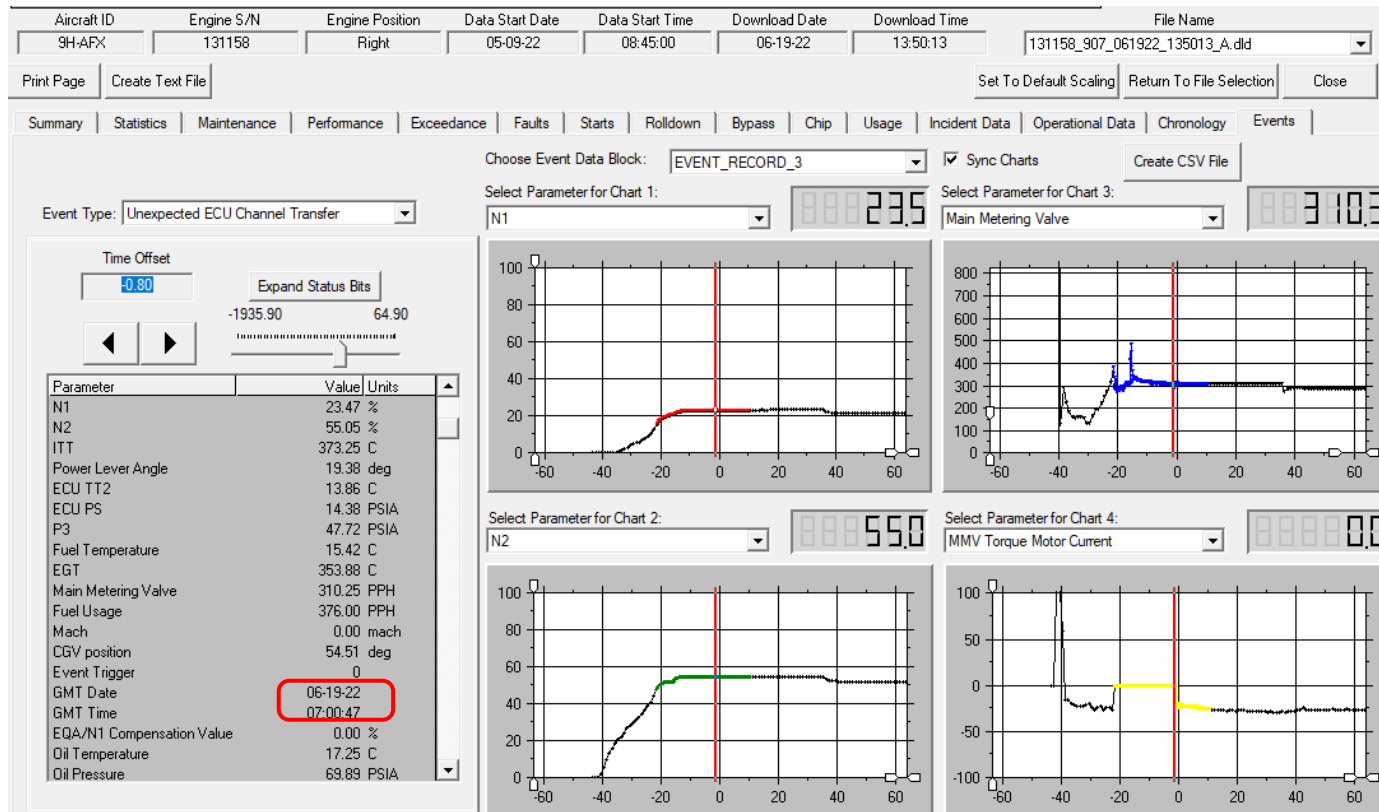
EEI REVIEW ENGINE P131158 – MMV & TM CURRENT

MMV torque motor current Null total time duration 21 seconds after engine start complete

AS907-3-1E P131158 - HMU fault MCID 0133
6/19/2022

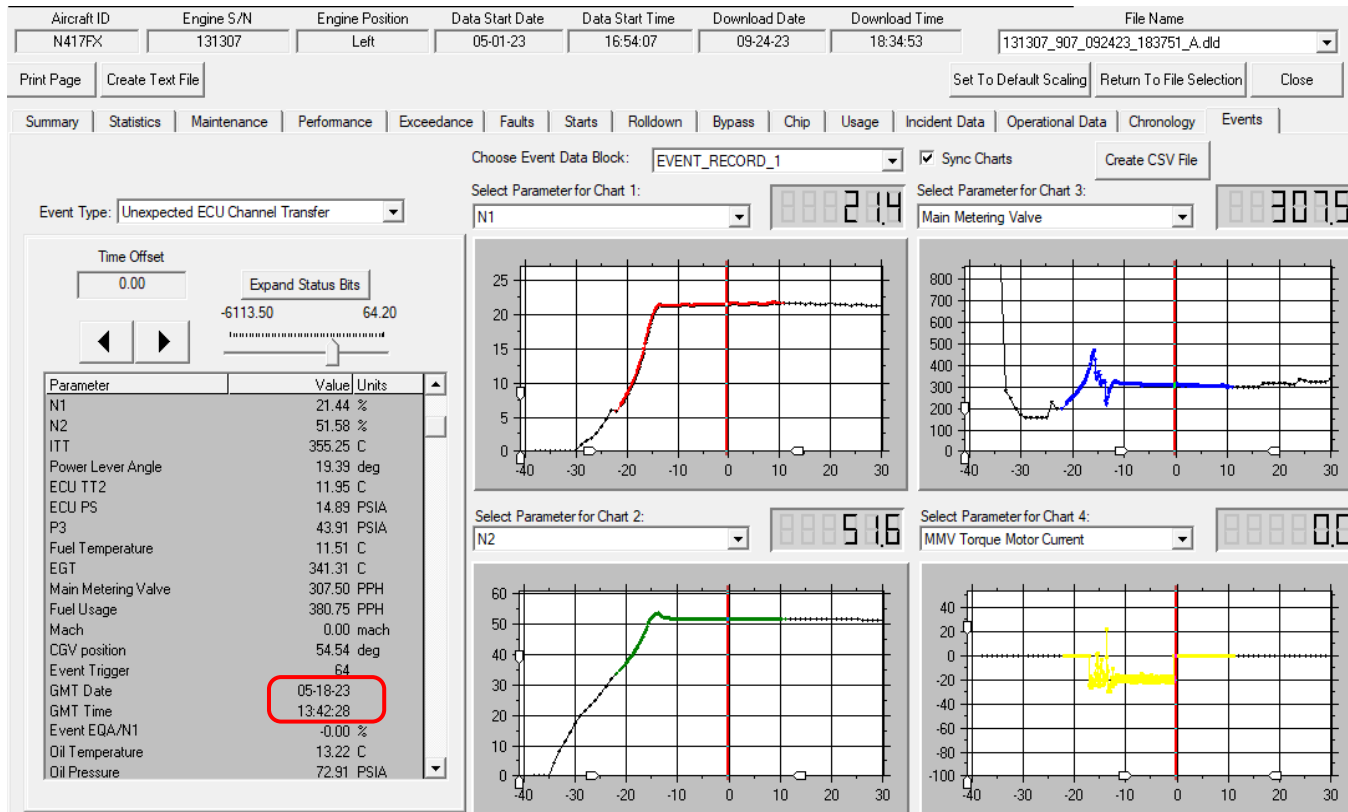
EEI REVIEW ENGINE P131307 – MMV & TM CURRENT

MMV current null MCID 133 occurs 8 secs after engine start complete

AS907-3-1E/P131307 - HMU fault MCID 0133

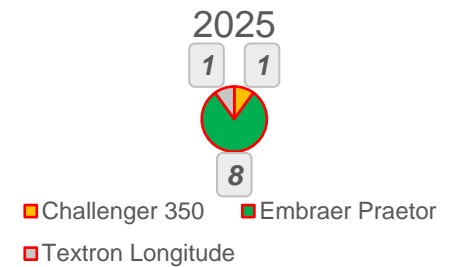
HMU REMOVALS PER AIRCRAFT MODEL 3-MONTH PERIOD

MCID 133 - Oct 2024 to Feb
