Honeywell Aerospace
1300 W. Warner Rd.
Tempe, AZ 85285

EFFECT OF UV-C ON AIRCRAFT INTERIOR MATERIALS

Version 2, September 25, 2020

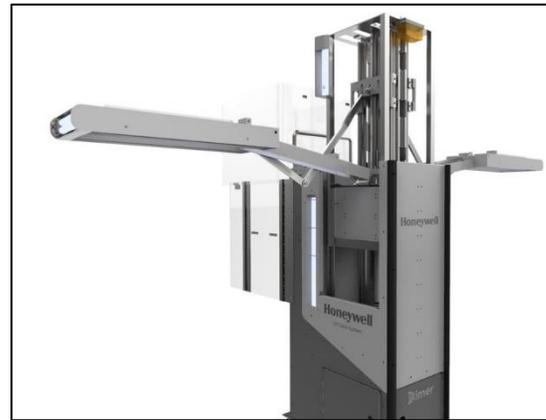
Figure 1: Honeywell UV Cabin System

The Honeywell UV Cabin System (Figure 1) is equipped with UV-C lamps and is wheeled through an aircraft cabin by an operator at a speed controlled by the operator with input from a speedometer to control level of dose. UV lights are mounted on two wings that extend over the seats of the aircraft and expose both the seats beneath the wings and the overhead compartment above them. Additional smaller UV lights are mounted on the wingtips for better exposure of the aircraft walls, on the body of the cart to expose the sides of the aisle, and near the crown of the cart to expose the overhead compartment doors. Since the incident angle for the UV light on a surface changes as the cart is moved, locations that are in shadow are reduced. The lights turn on only when an operator has his/her hands on the controls, and the operator is shielded from the UV light by clear shields tested for UV safety. The relationship between the UV dose provided by this system and UV doses required to inactivate tested pathogens are described in a related white paper.²

The Honeywell UV Cabin system employs 253.7nm UV-C light and exposes materials in the cabin of an aircraft to UV-C light during use at doses which depend on the location and proximity to the material being treated and the time of treatment. All UV-C effects on materials are dose-dependent. Dose can be generally measured by the light intensity and time, so the same effect can be observed with low intensity over a long period of time or high intensity for a short time. Since the intensity of the light on a surface will depend on the distance between the surface and the light source, and the angle between the plane of the surface and the incident light, it will be different for different positions in the aircraft. The cumulative dose experienced by materials in the cabin can be estimated by multiplying the single treatment dose by the number of treatments per day, and the number of treatment days.

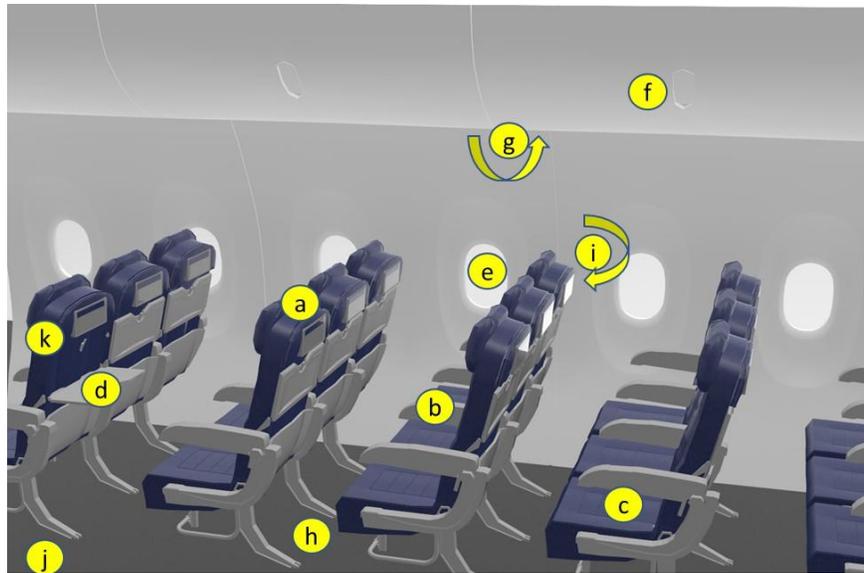
Figure 2: Dose Measurement Locations in Aircraft

Dose measurements have been taken using the Honeywell UV Cabin System at positions corresponding to many locations in a typical narrow body aircraft. The measurements were made by placing an ILT800-CUV radiometer in each location and moving the UV system through the test area at the indicated speed. Figure 2 shows the measurement locations, and Table 1 shows the measured single treatment doses. Note that, except as indicated, the dose corresponds to two passes (forward and back) down the aircraft cabin aisle. The table also shows the number of treatments required to reach the doses used in color evaluation studies, and the number of years of use required to reach this number of treatments. Dose measurements for 10 rows/minute are provided to show dose examples for speed which can be used to treat areas of higher risk.

Location	Description
a	Top of Aisle headrest
b	Top of Armrest
c	Seat Cushion Aisle
d	Top of Tray table (1 pass)
e	Aircraft Window
f	Overhead luggage handle
g	Passenger service unit
h	Floor in front of aisle seat
i	IFE screen
j	Cabin Aisle Floor
k	Side of Aisle headrest

Description	Treatment dose (mJ/cm ²)		Number of treatments to reach cumulative dose (30 rows/min treatment)			Years of use at 1 treatment/day (30 rows/min treatment)		
		10 rows/min	30 rows/min	17 J/cm ²	34 J/cm ²	51 J/cm ²	17 J/cm ²	34 J/cm ²	51 J/cm ²
a	Top of Aisle headrest	39.0	13.0	1,311	2,622	3,933	3.6	7.2	10.8
b	Top of Armrest	28.2	9.4	1,806	3,613	5,419	4.9	9.9	14.8
c	Seat Cushion Aisle	21.3	7.1	2,387	4,774	7,161	6.5	13.1	19.6
d	Top of Tray table (1 pass)	15.9	5.3	3,235	6,469	9,704	8.9	17.7	26.6
e	Aircraft Window	10.2	3.4	5,055	10,109	15,164	13.8	27.7	41.5
f	Overhead luggage handle	10.5	3.5	4,902	9,805	14,707	13.4	26.9	40.3
g	Passenger service unit	9.6	3.2	5,238	10,476	15,714	14.4	28.7	43.1
h	Floor in front of aisle seat	18.3	6.1	2,777	5,554	8,330	7.6	15.2	22.8
i	IFE screen	21.0	7.0	2,429	4,857	7,286	6.7	13.3	20.0
j	Cabin Aisle Floor	15.3	5.1	3,305	6,609	9,914	9.1	18.1	27.2
k	Side of Aisle headrest	27.3	9.1	1,861	3,723	5,584	5.1	10.2	15.3

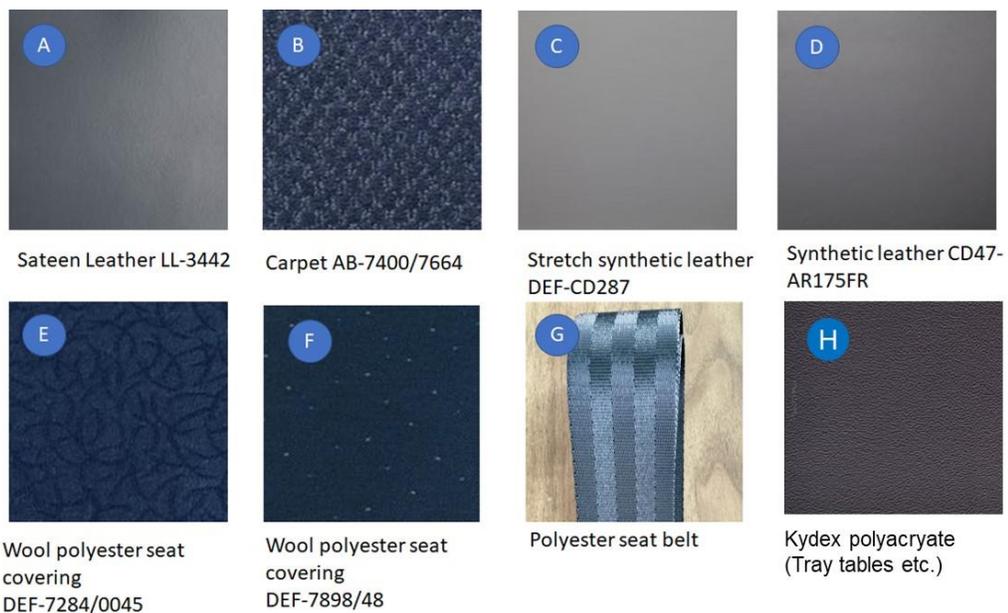
Figure 3: Samples used in materials study

Materials testing was completed in June - September 2020 at the Honeywell Aerospace Advanced Technology lab in Des Plaines, IL. Samples of materials used in the referenced testing are shown in Figure 3 and include fabrics for seats and carpets, seat belts and plastics typically used in tray tables, etc. Testing for each material was completed with a single batch or roll of material. Samples were exposed to UV-C light in a Rayonet reactor (Figure 4) equipped with 16 mercury vapor UV-C lamps arranged around the circumference of a cylinder of UV-reflective material. For soft materials like fabrics, samples were cut into the sizes appropriate for the analysis and wrapped around a length of PVC pipe. This pipe was centered in the center of our reactor and rotated slowly during the UV exposure (Figure 5). Rigid materials were suspended on a wire in the center of the reactor. A fan in the base of the reactor kept the temperature during exposure within 10°C of room temperature.

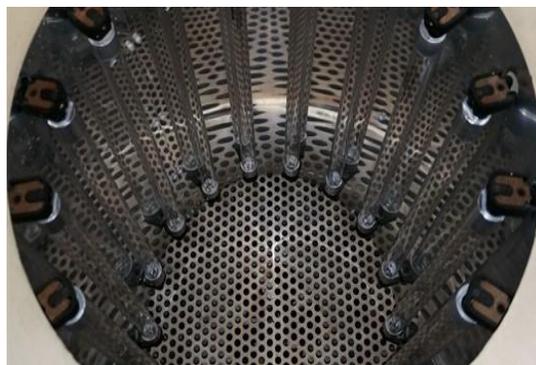
Figure 4: Reactor used for UV-C materials stability exposures

1. Using a UV-C radiometer, the UV intensity was measured at intervals around the reactor, with the radiometer positioned at the same distance from the surrounding ring of lamps as the samples. These measurements were averaged to provide a single intensity.
2. A programmable timer was used to supply the AC power to the reactor. Various times were used to provide the doses shown in the tables below. Intensity multiplied by (x) time provided the dose.

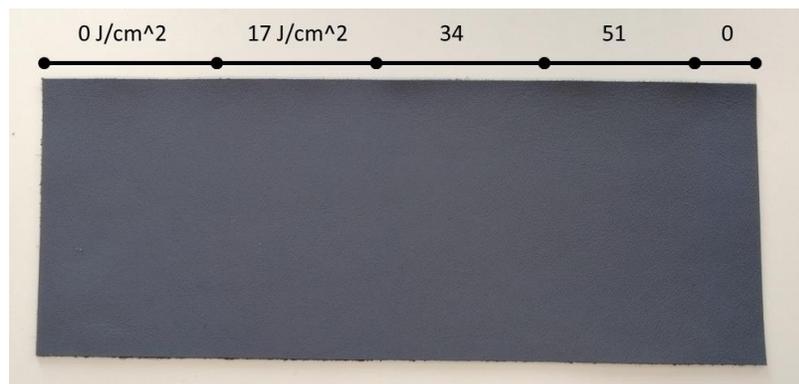
Figure 6: Progressive UV-C Exposure for Sateen Leather

Summary: As indicated in Table 2 and 3 below, UV-C exposure testing resulted in no significant effect on tensile strength, tear strength or flame retardancy of the sateen leather. At higher doses, a slight change in color was observed. According to the dose table, and using the most heavily exposed part of the seat (top of aisle headrest), the highest dose corresponds to 10.8 years of use (30 rows/min, 365 treatments/year).

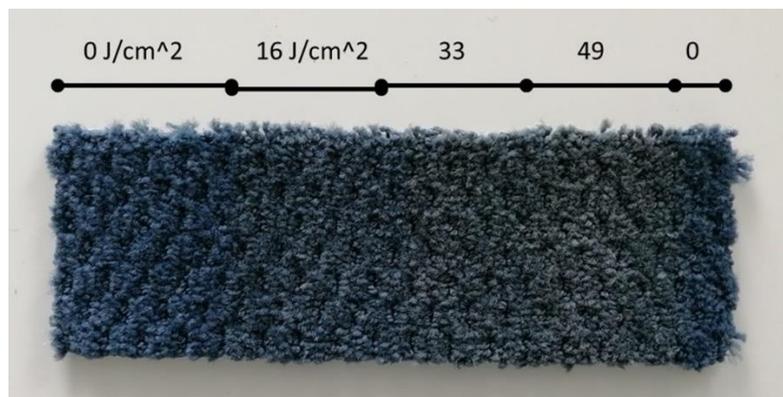
Figure 7: Progressive UV-C Exposure for Nylon Carpet

Summary: As indicated in Tables 4 and 5 UV-C exposure testing resulted in no significant change in tensile strength, tear strength or flame retardancy of the nylon carpet. Fading in carpet color is first visible at 34 J/cm² dose. Using the dose information above, this would correspond to 15-18 years of use (30 rows/min, 365 treatments/year).

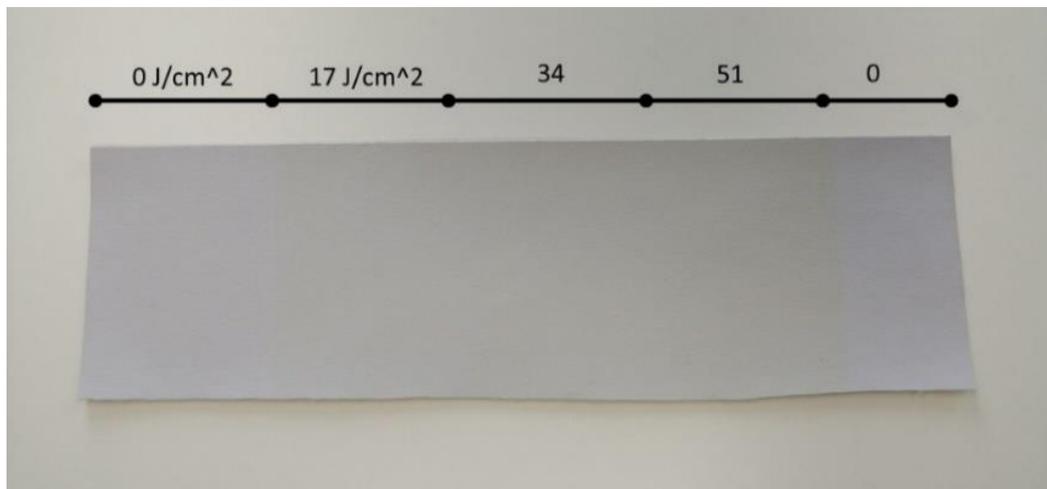
Figure 8: Progressive UV-C Exposure for Columbia Synthetic Leather

Summary: As is indicated in Tables 6 and 7, UV-C exposure testing resulted in no significant effect on tensile strength, tear strength or flame retardancy of the synthetic leather. Yellowing of the material was first observed after doses of 17-34 J/cm², corresponding to 4-7 years of daily use at the most exposed location (aisle headrest, 30 rows/min, 365 treatments/year).

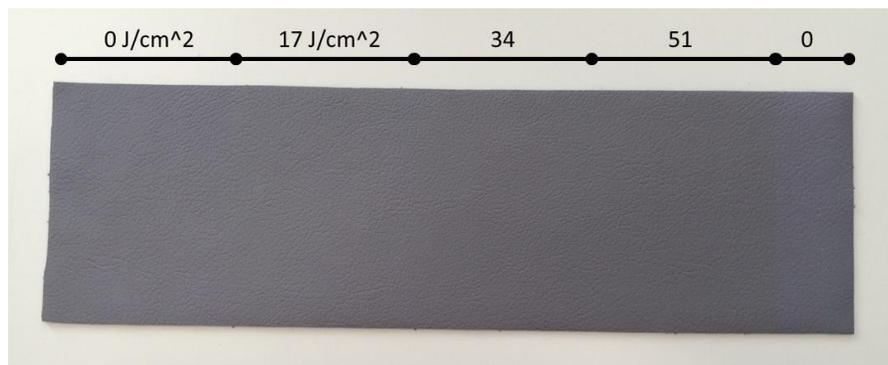
Figure 9: Progressive UV-C Exposure for Luxaire Synthetic Leather

Summary: As indicated in Tables 8 and 9, UV-C exposure testing resulted in no significant impact on tensile strength, tear strength or fire retardancy of this synthetic leather. It darkened slightly at the highest UVC dose (51 J/cm², corresponding to 10.8 years using 30 rows/min treatment rate and 365 treatments/year).

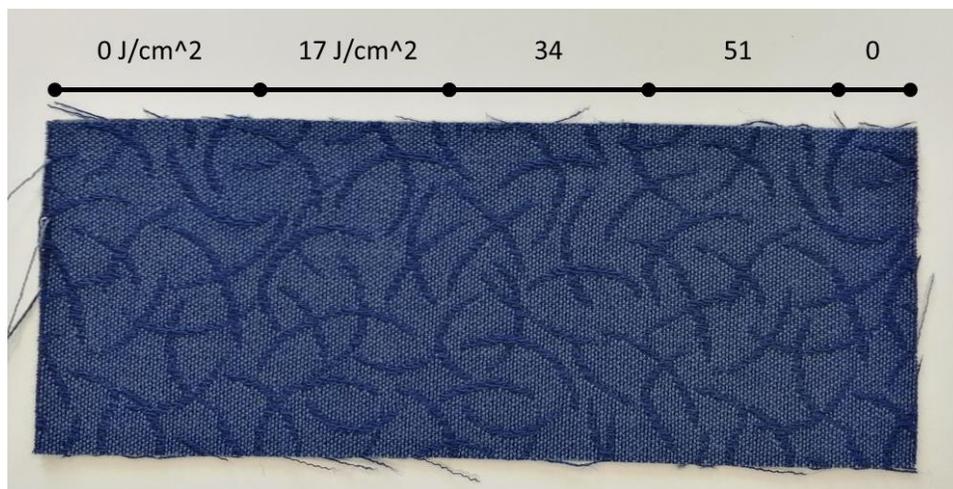
Figure 10: Progressive UV-C Exposure for Wool-Polyester

Summary: As indicated in Table 10 and 11, UV-C exposure testing resulted in no significant effect on tensile strength, tear strength, or fire retardancy of this wool-polyester blend. It also showed no visible effect of UV-C on color or appearance.

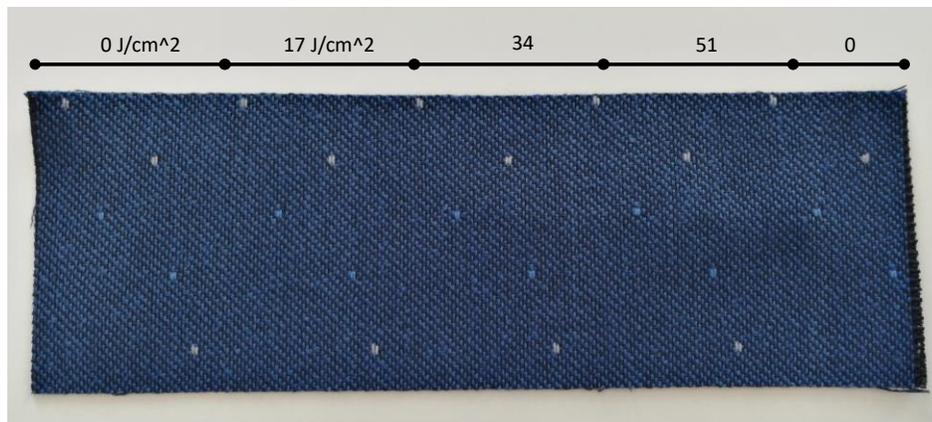
Figure 11: Progressive UV-C Exposure for Wool-Polyester

Summary: As indicated in Tables 12 and 13, UV-C exposure testing resulted in no significant effect on tensile strength, tear strength, or fire retardancy of this wool-polyester blend. It also showed no visible effect of UV-C on color or appearance.

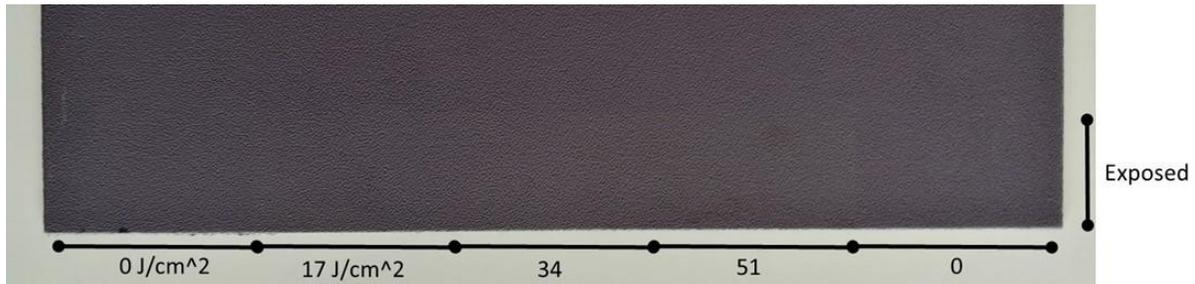
Figure 13: Progressive UV-C Exposure for Kydex

Summary: This polyacrylate material is frequently used as the surface for plastic cabin materials including tray tables and other surfaces. The exposure testing showed no detectable change in color on UV exposure.

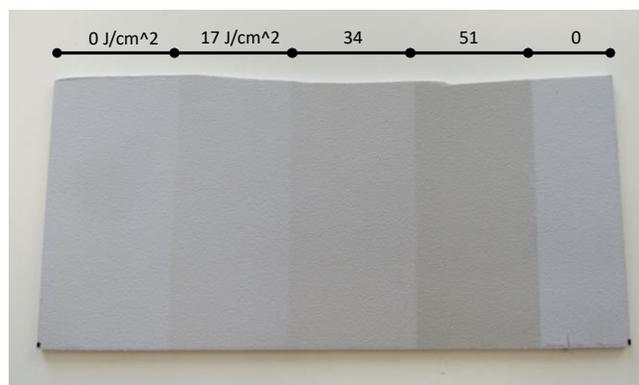
Figure 14: Progressive UV-C Exposure for Boltaron 9815N

Summary: According to the manufacturer, Boltaron 9815N is used for tray tables, aircraft seat shells and other applications. As Table 16 shows, UV-C had no effect on flame retardancy. Some color change was observed with this material after UV exposure. If this material were used for a tray table, with a single treatment dose of 5.3 mJ/cm², then the 34 J/cm² cumulative dose shown in Figure 14 would correspond to 6469 treatments.

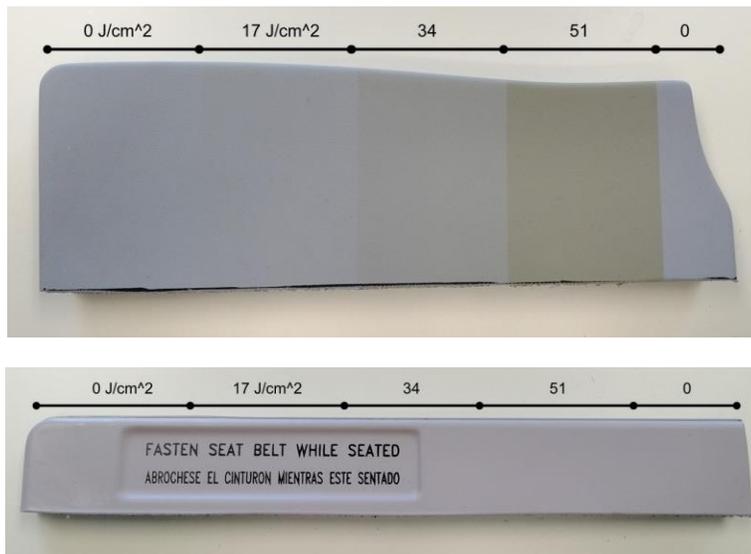
Two samples of tray tables were supplied by an airline for evaluation. The tray tables were cut into smaller pieces suitable for UV-C exposure in the Honeywell test chamber and were exposed using the progressive masking technique. Honeywell's recommended approach is to make one pass with the tray tables down and a second with them up to expose the seat cushions and the back of the tables instead. Using this approach, a single treatment would give a dose of 5.3 mJ/cm^2 . With this assumed cumulative dose increment of 17 J/cm^2 would correspond to 3207 treatments (8.8 years at 1 treatment/day). We observed different UV sensitivity for the small blue tray table compared with the larger gray one. As Figure 15 below shows, yellowing was observed for the blue tray tables beginning at 34 J/cm^2 and becoming more extreme at 51 J/cm^2 . 34 J/cm^2 is equivalent to 17.7 years of treatments at one treatment/day and 51 J/cm^2 is equivalent to 26.6 years of treatments at one treatment/day. If this tray table were exposed at these doses an average of four times/day, the color change occurring at 51 J/cm^2 would occur after 6.5 years and the color change at 34 J/cm^2 would occur at 4.5 years. In contrast, the larger tray tables did not show discoloration with UV-C light.

Figure 15: Tray tables after progressive UV-C exposure. Top: Small blue tray table, Bottom: Larger gray tray table.

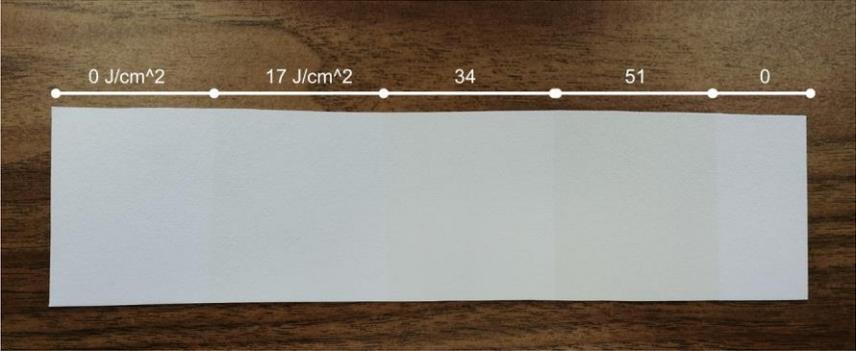
Figure 16: Window shade after progressive UV-C exposure

A window shade was cut into sections, and one such section was used for a progressive color evaluation, using the same approach and the same intervals as for the tray tables. Since window shades receive less UV-C light from the Honeywell UV-C system (3.4 mJ/cm^2 for a two exposure treatment) the 17 J/cm^2 increment corresponds to an increment of 5,000 treatments (13.7 years at 1 treatment/year). Figure 16 below shows the results from this study. We observed initial yellowing at 34 J/cm^2 , and a bit more intense yellowing at 51 J/cm^2 . 34 J/cm^2 is equivalent to 27.7 years of treatments at one treatment/day and 51 J/cm^2 is equivalent to 41.5 years of treatments at one treatment/day. If this window shade were exposed at these doses an average of four times/day, the color change occurring at 34 J/cm^2 would occur after 6.9 years and the color change at 51 J/cm^2 would occur at 10.4 years.

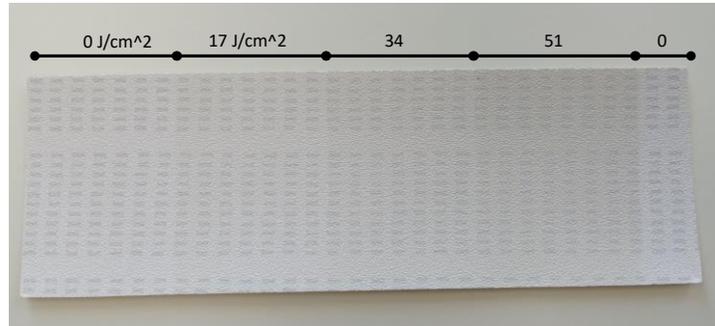
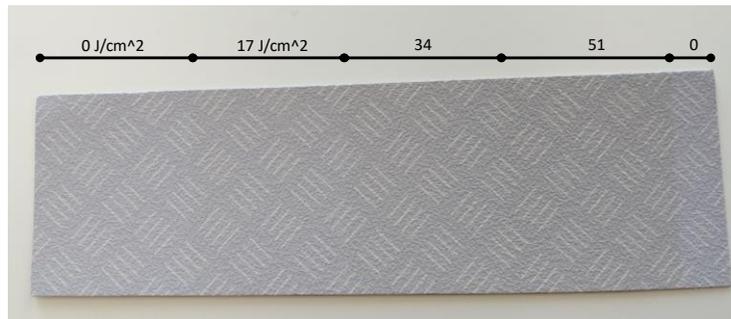
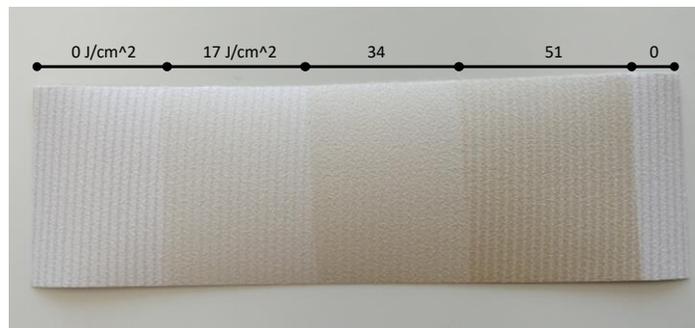
Summary: Three samples of aircraft interior decorative laminate were received. Each was exposed to UV-C using the progressive exposure approach. All three showed yellowing at higher UV-C doses. Samples P/N S016329 and P/N S05051-011-H5 were marked as containing a heat-activated adhesive. Further experimentation will be required to understand whether the observed color changes resulted, in part or completely, from this adhesive. Referring to Table 1, a dose of 17 J/cm² would correspond to 5055 treatments at the 30 rows/minute treatment rate.

Figure 18: Schneller decorative foil laminate (P/N S3863)

**Figure 19: Schneller decorative foil laminate (P/N S016329)
(Includes heat activated adhesive)**

**Figure 20: Schneller decorative foil laminate (P/N S05051-011-H5)
(Includes heat activated adhesive)**

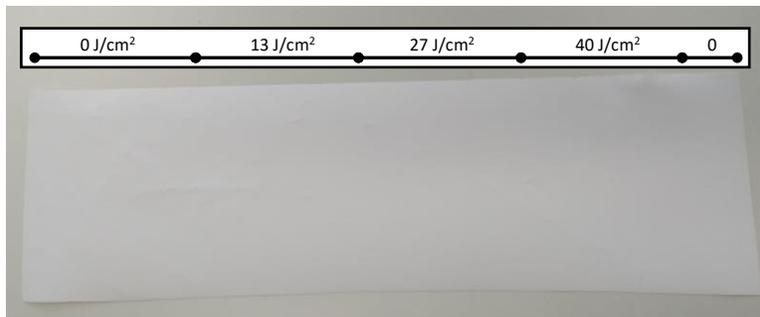
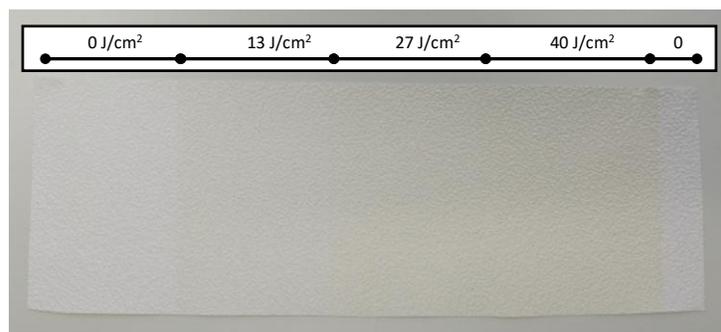
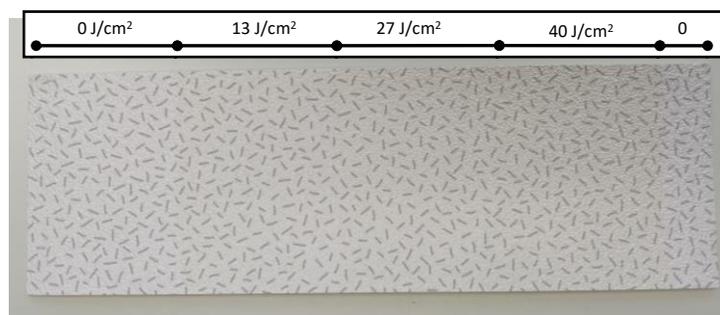
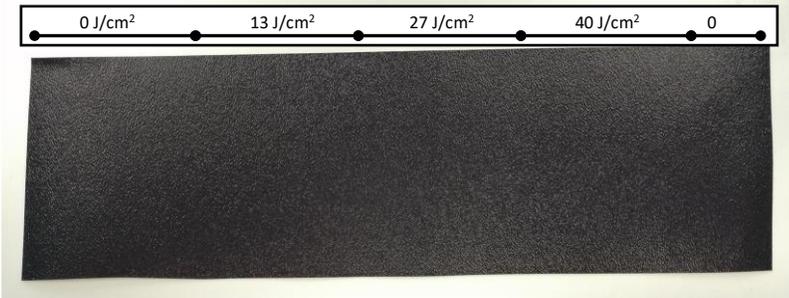
Summary: Referring to the photographs, we could discern no change in color in response to UV-C light for samples A and D. Samples B and C did experience progressive yellowing, first detectable at 13 J/cm² for Sample B and at 27 J/cm² for Sample C. Based on our radiometry and using a typical treatment rate of 30 rows/minute for the Honeywell unit, these cumulative doses would correspond to 3993 or 7986 treatments, or, assuming one treatment per day, 10.9 or 21.9 years of use. Honeywell is not aware of the provenance of these samples, and particularly whether they contain heat-activated or pressure sensitive adhesives. If these are present, they would contribute to color generation in a way that would not be faithful to how the same laminates would react after use in an aircraft.

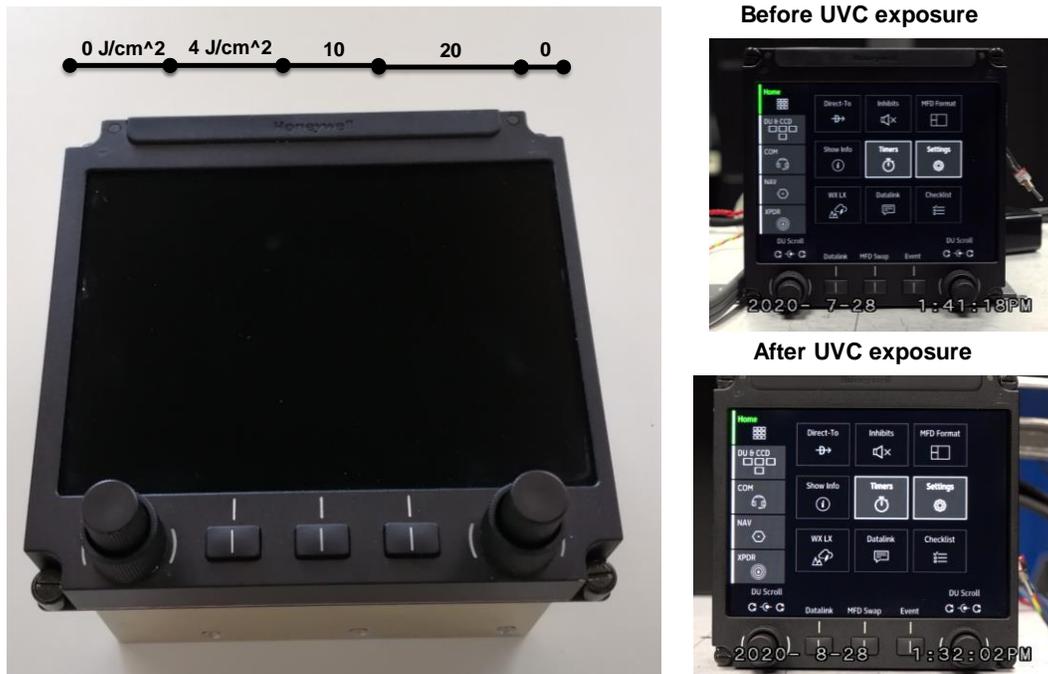
The TSC 2.0 is a Honeywell cockpit touchscreen display common product currently fielded for the Pilatus PC-12 and PC-24 aircrafts. UV-C exposure testing was completed on the TSC 2.0 to validate lifetime exposure limits of the unit. Exposure on the unit varied from 0 J/cm² to 20 J/cm². Measurements and pictures were taken pre and post exposure. A visual inspection shows no detectable changes to the display, bezel, or buttons. Quantitative luminance and chromaticity measurements of the display were taken at screen center in the 10 J/cm² exposure area of the LCD, these measurements can be seen in the table below. These measurements show negligible change pre to post UV-C exposure. The small amount of change in luminance and chromaticity can be accounted for by test setup and measurement equipment normal variations.

Figure 25: Honeywell TSC 2.0 cockpit touchscreen display. Left: UV progressive doses; Right: Before and after display.

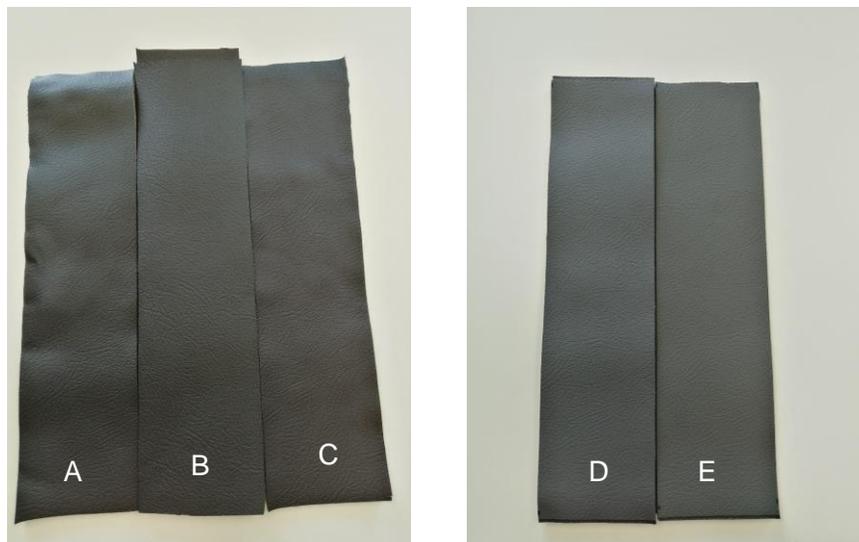
The leather seat coverings were cut into 3 x 12" sections for flame retardancy studies. Three control samples received no UV-C exposure, while other sections received doses of 185 and 365 J/cm². Using a single treatment dose of 13 mJ/cm² as measured for the most exposed section of a typical airline seat (aisle headrest, 30 rows/min exposure speed, 2 exposures/treatment), a cumulative dose of 185 J/cm² would correspond to 14,230 treatments (39 years at 1 treatment/day). Leather has been, in our experience, one of the most resistant materials to UV-C light, and we observed no color difference between the control and exposed samples in Figure 27. The samples were sent to AeroBlaze for the FAA vertical burn measurement, and, as the results in Table 20 show, there was no significant effect of UV-C light on flame retardancy.

Figure 27: Leather Seat Coverings. Group 1: A No UV-C exposure, B 185 J/cm², C 365 J/cm²; Group 2: D No UV-C exposure, E 365 J/cm²

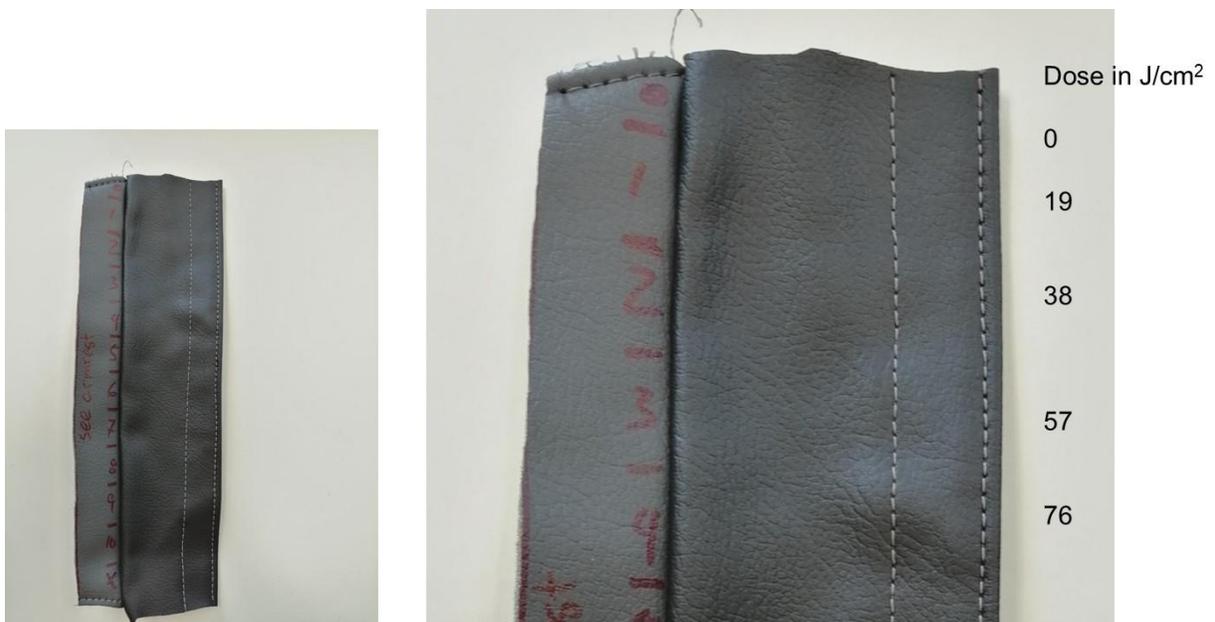
The leather armrest provided appears to be the same leather as that used for the seat covering. It was used for a progressive color test by masking the sample with tape, and progressively unmasking it after incremental exposures to UV-C light. Each incremental dose was 19 J/cm^2 . Using our measured UV-C dose of 9.4 mJ/cm^2 (one treatment equals two exposures at 30 rows/min treatment speed), a cumulative dose of 19 J/cm^2 would correspond to 2021 treatments (5.5 years at 1 treatment/day). Figure 28 below shows the complete armrest, which received 10 incremental doses, and an expanded view on the upper portion spanning doses between 0 and 76 J/cm^2 . No detectable change in color is apparent.

Figure 28: Leather armrest after progressive UV-C exposure. Photo on right is close up of the upper portion of the left photo, with UV-C dose marked.

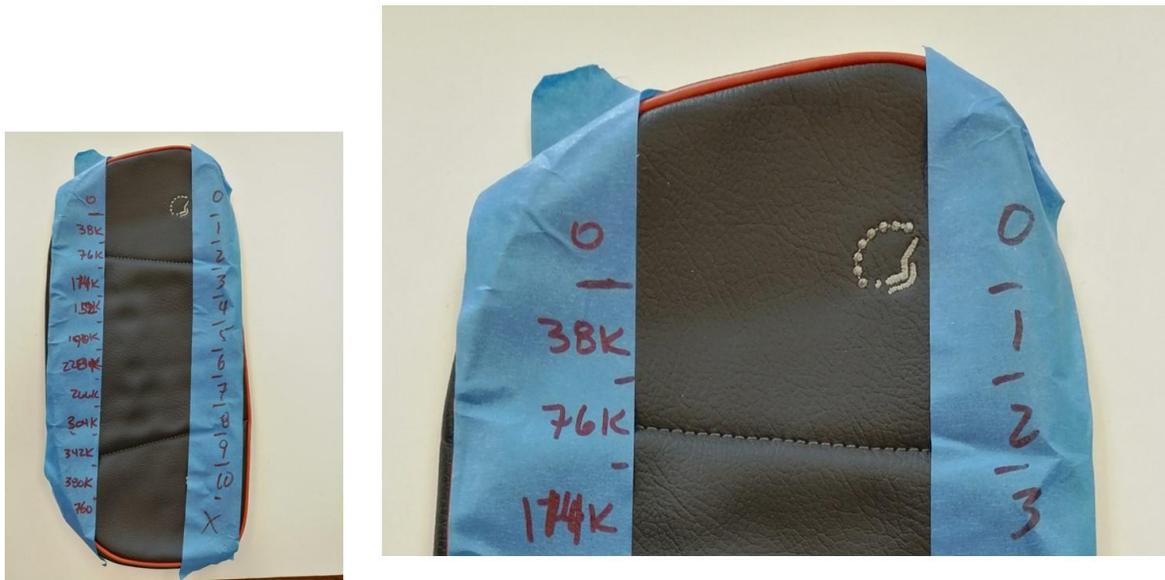
A leather headrest was similarly exposed using the progressive approach at Dimer LLC. The Figure below shows this sample, with the exposure “stripes” indicated by the applied tape. For this sample the increment between doses was 38 J/cm^2 . As with the seat covering and the armrest, we do not see any change in appearance for this material.

Figure 29: Leather armrest after progressive UV-C exposure. Photo on right is close up of the upper portion of the left photo, with UV-C dose marked.

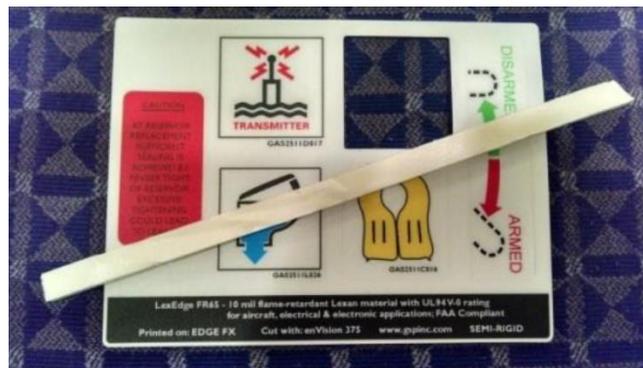
Figure 30. Colored Label Sample, Before Exposure

Gerber supplied a 6" x 4.5" LexEdge FR65-10mil label for testing. The sample had a white background with black, red, yellow and blue colors. A strip of white foam tape was placed across the sample to partially cover each color (see photo, Figure 30).

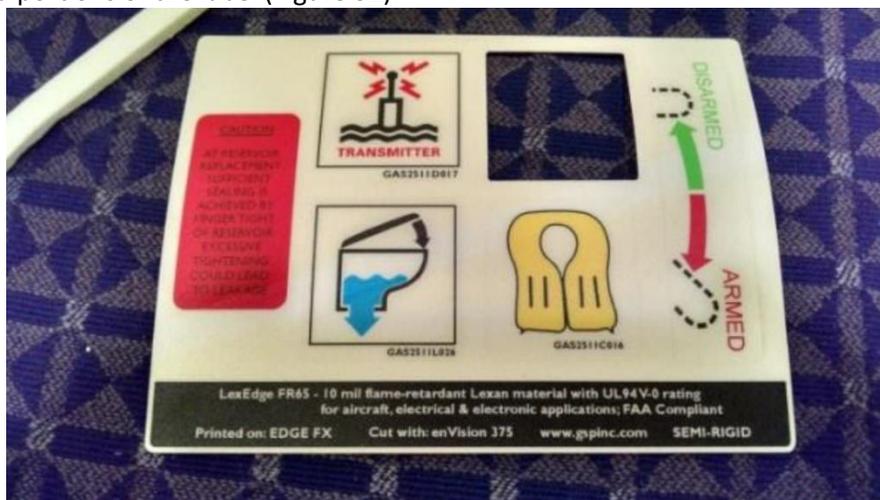
Figure 31. Colored Label Sample, After Exposure

At the conclusion of the test, we did not detect any visual or tactical differences between the exposed and unexposed portions of the label (Figure 31).

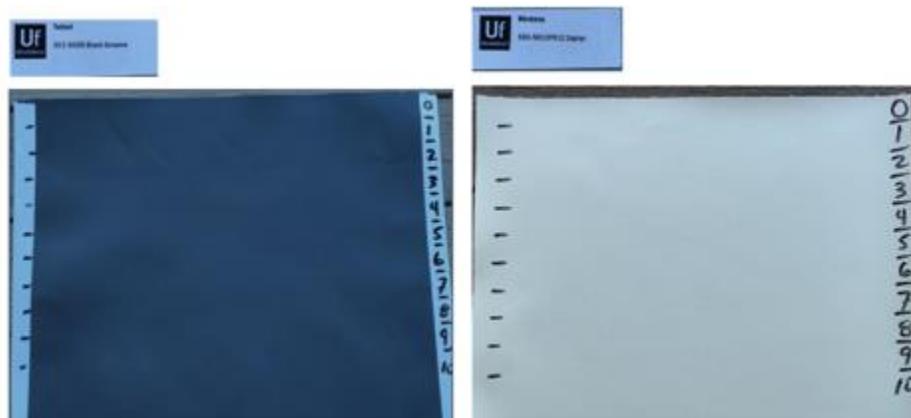
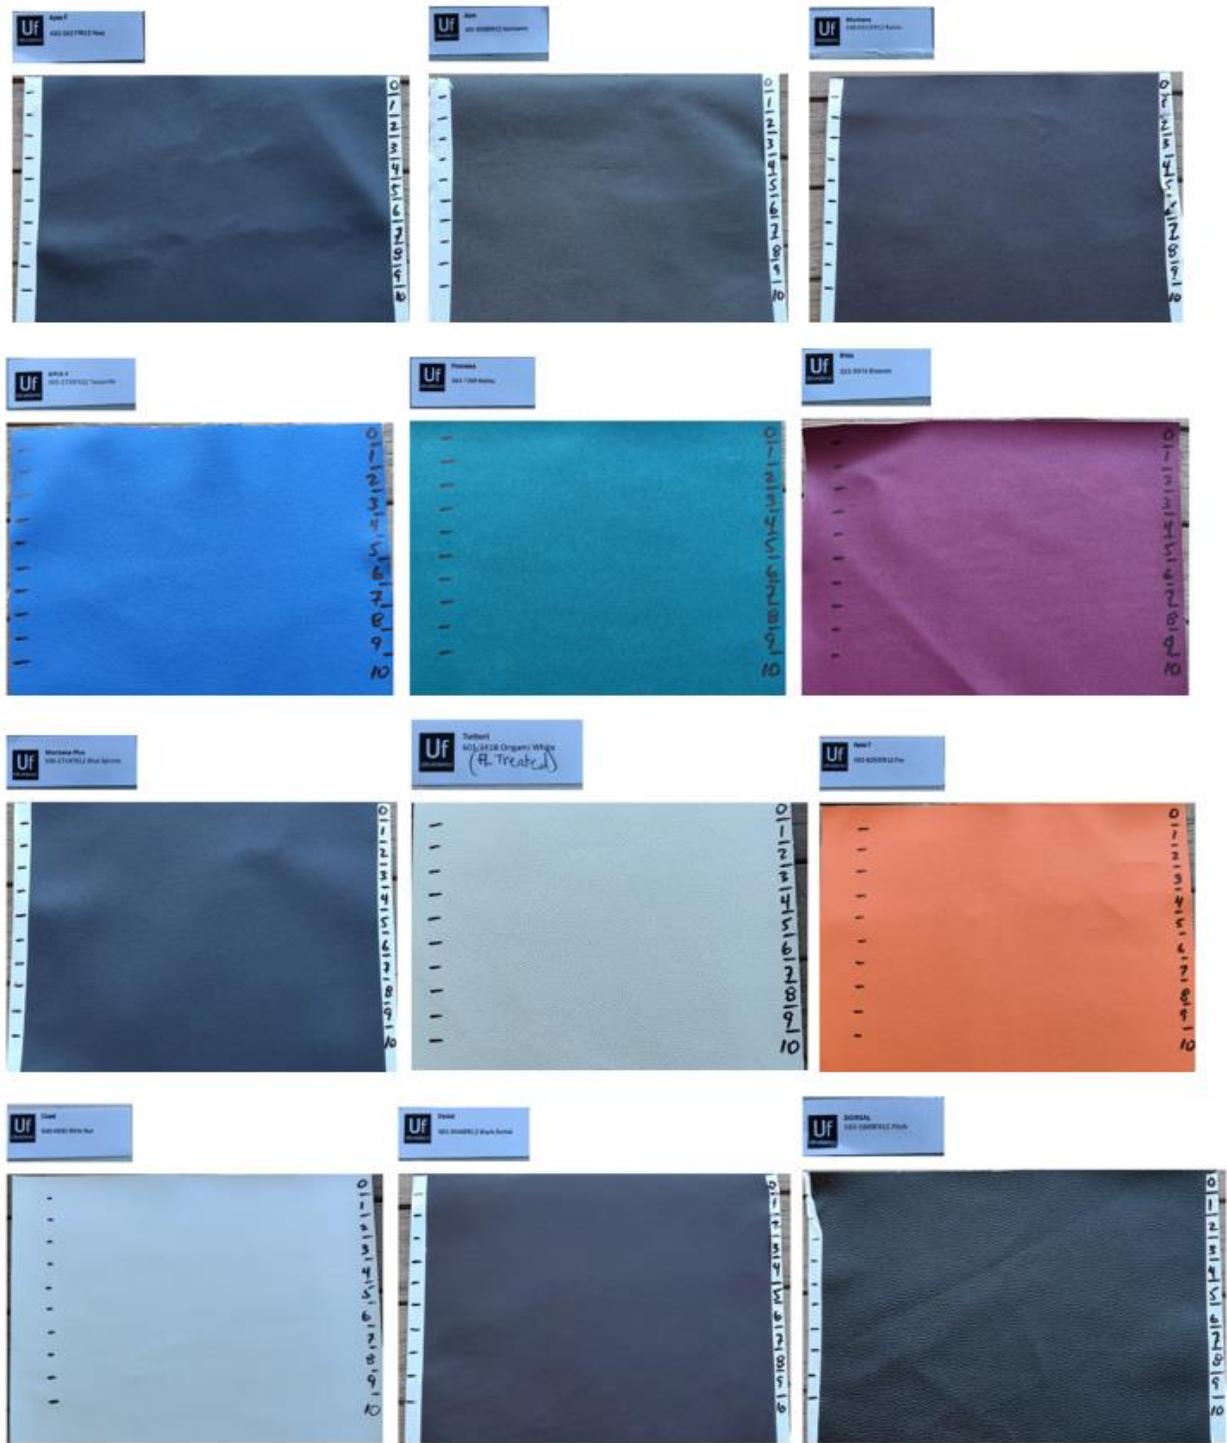
Figure 32. Ultrafabrics Samples, Progressive Exposure to 40 J/cm²

After the exposure, all fourteen Ultrafabrics samples tested revealed no detectable color change at any exposure levels. For all samples tested, the tactile "feel" as well as bending properties appeared unchanged, with no cracking visible under magnification. No formal material testing pre and post exposure was performed. The following figures show the samples tested with the progressive exposure bands marked to the right hand side of each picture (0: no exposure, 10: 40 J/cm², with 4 J/cm² increment at each progressive band).

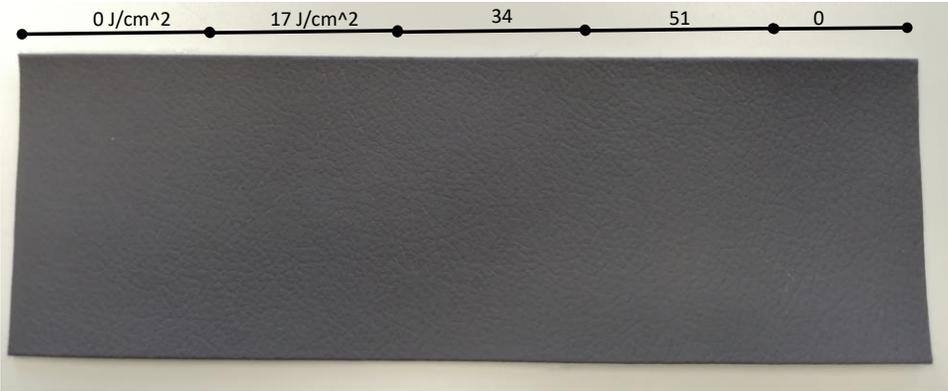
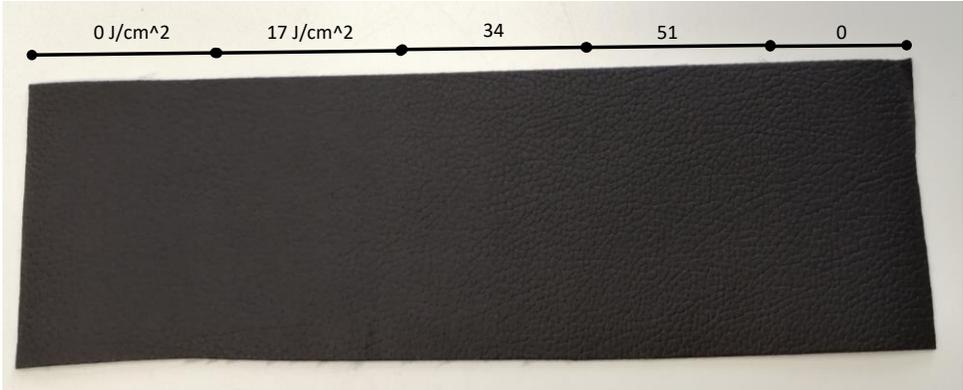
Figure 34. Ultrafabrics 492-6022FR12 Hydra (Gray), Progressive Exposure

Figure 35. Ultrafabrics 590-5012FR12 Zephyr (Black), Progressive Exposure

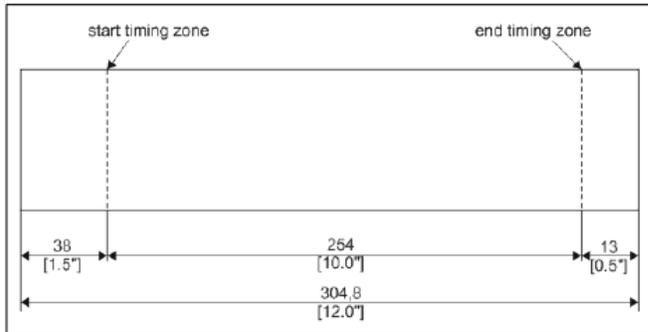
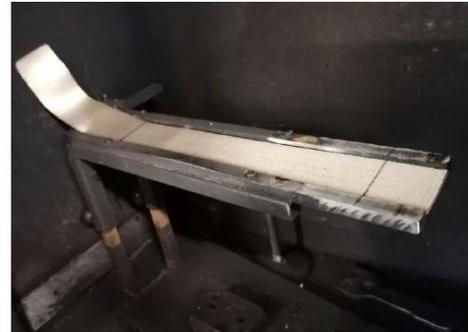
Figure 37. Seat Belt Flame Resistance, Test Set-up

Flame resistance was tested in accordance to SAE AS 8043 Para. 10 on samples with simulated UV-C exposure of 2 years and 10 years (3 samples each). Per specification, the flame is applied to the specimen for 15 seconds and then removed. The time is recorded when the marking of the timing zone is reached by the flames. If the flames do not reach the marking “end timing zone” within 4 minutes, the flames are extinguished, and the burning length is recorded (Figure 37). Per AS 8043 para. 3.10, for parts tested in accordance with the procedure of Section 10, where the specimen is tested horizontally, the average burn rate shall not exceed 63.5 mm per minute. A slightly decrease of the flammability resistance was determined comparing the flammability results of the samples simulated UV-C exposure of 2 years and 10 years, however all test samples passed the required values.
